# Inspection Report

## Thorough Check Building Inspections

**25 Cherl Avenue, Terrigal, NSW, 2260**

### Pest And Building Inspection

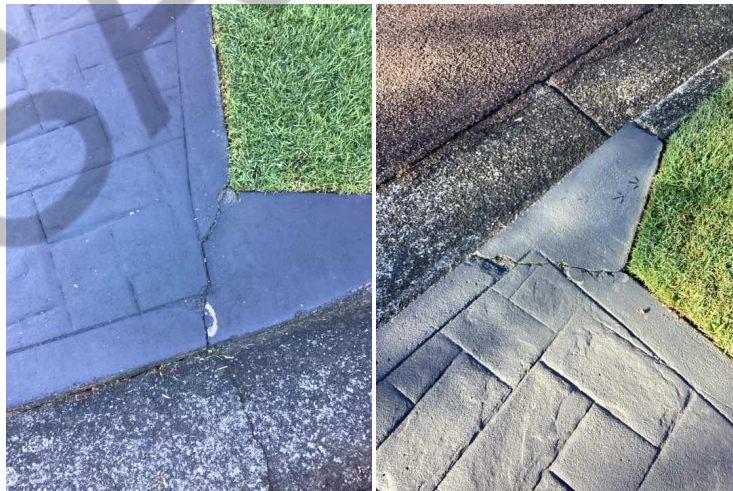
Common cracks were observed on the driveway. Whilst these cracks appeared to be typical at the time of inspection, we strongly recommend you monitor these cracks and if worsening occurs contact a concreter for further advice.

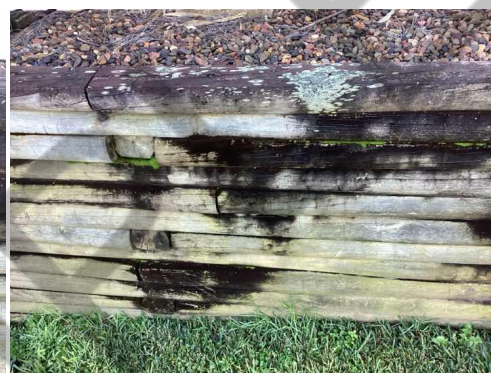
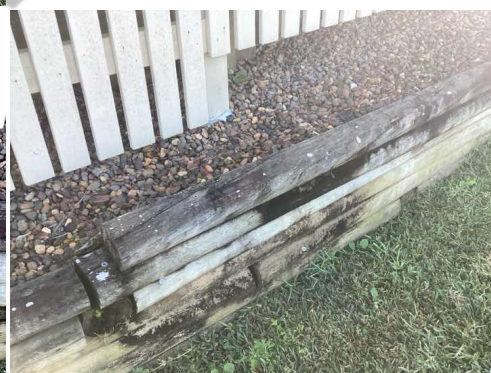
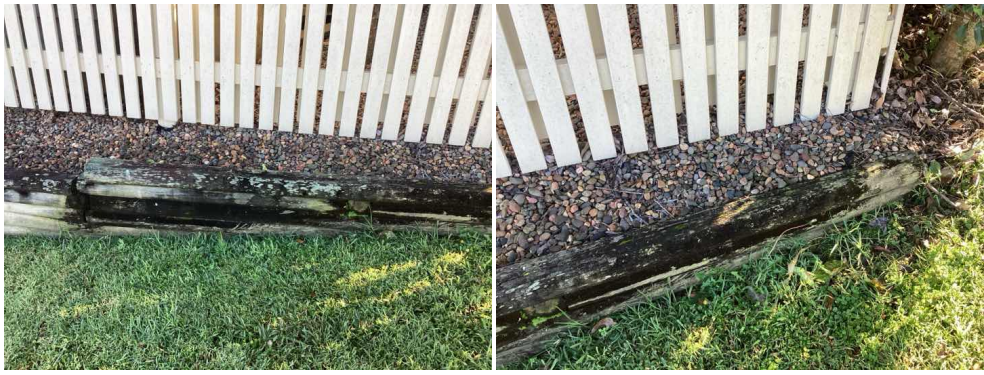
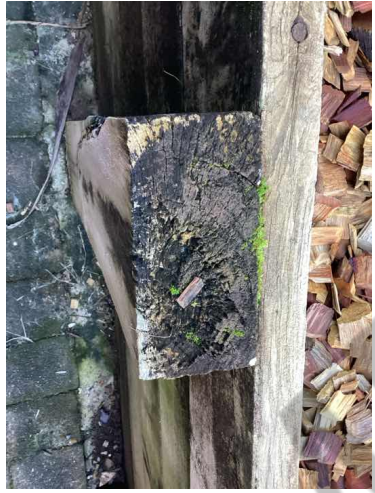
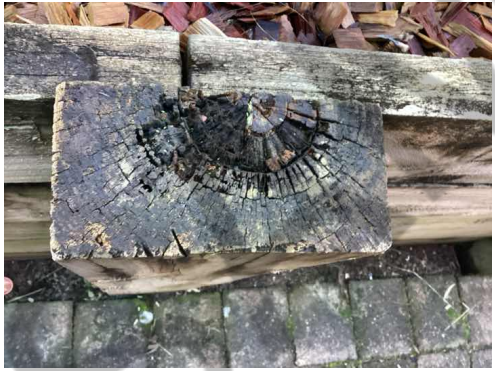
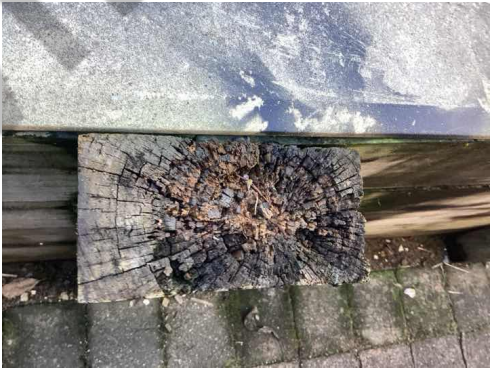
Timber fungal decay evident. Recommendations: A qualified landscaping contractor should be engaged for repairs and recommendations.

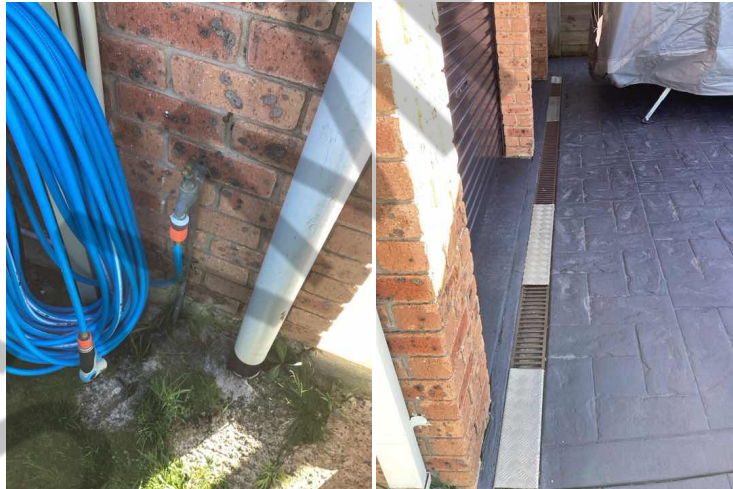
Recommend installing a drainage point under the tap to assist with drainage.

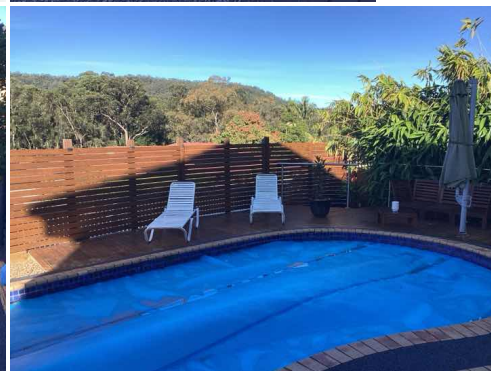
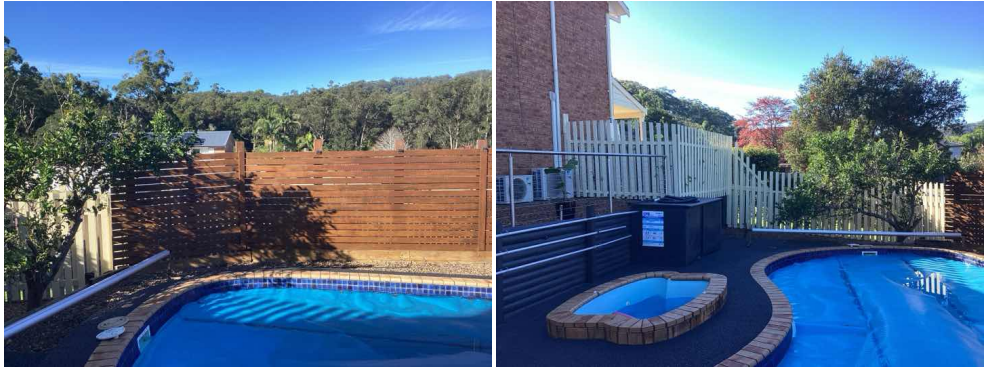
A swimming pool is present but the pool fence appears inadequate. The gate is not closing and latching as it should. This should be repaired. The pool fence should be checked for compliance with safety regulations. Considered safety Hazard

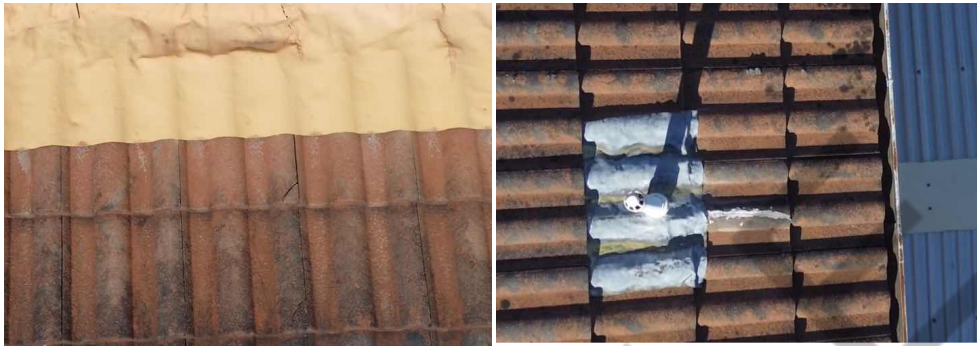
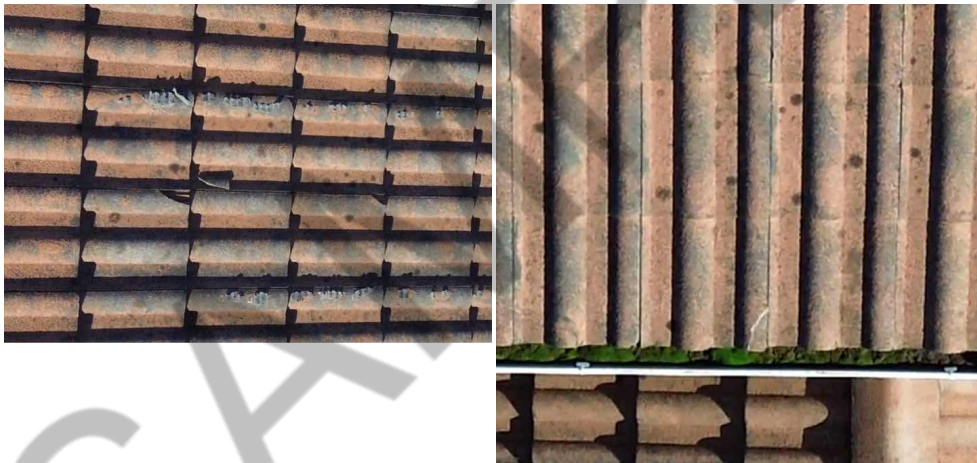
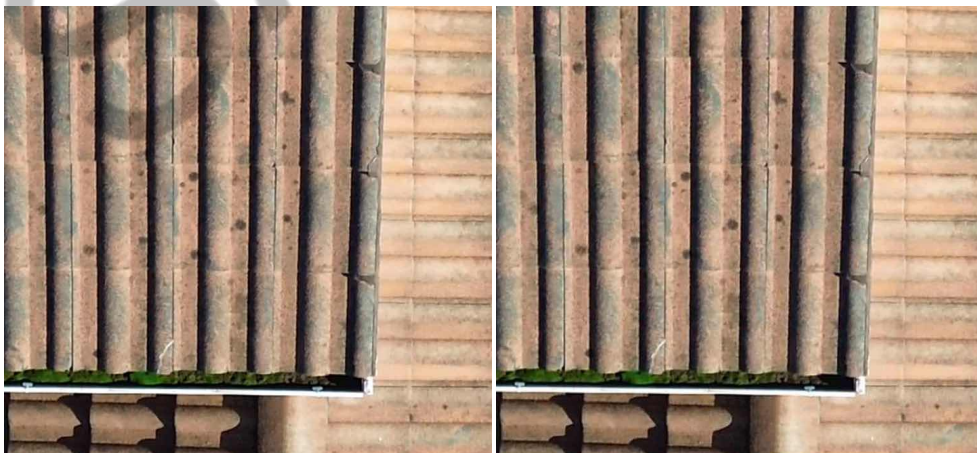
Cracked tiles visible. Contact a roof tiler for repairs. This has potential to become a serious issue if repairs aren't carried out due to water ingress into the roof cavity.

Mortar cracks visible. We recommend having these repaired by a qualified roofer as they may contribute to water ingress.

Cracked tile ends visible. A qualified roof tiling contractor should be engaged for advice and recommendations. Considered a minor defect but has the potential to become a Major defect if repairs aren't carried out immediately due to water ingress into the roof cavity.

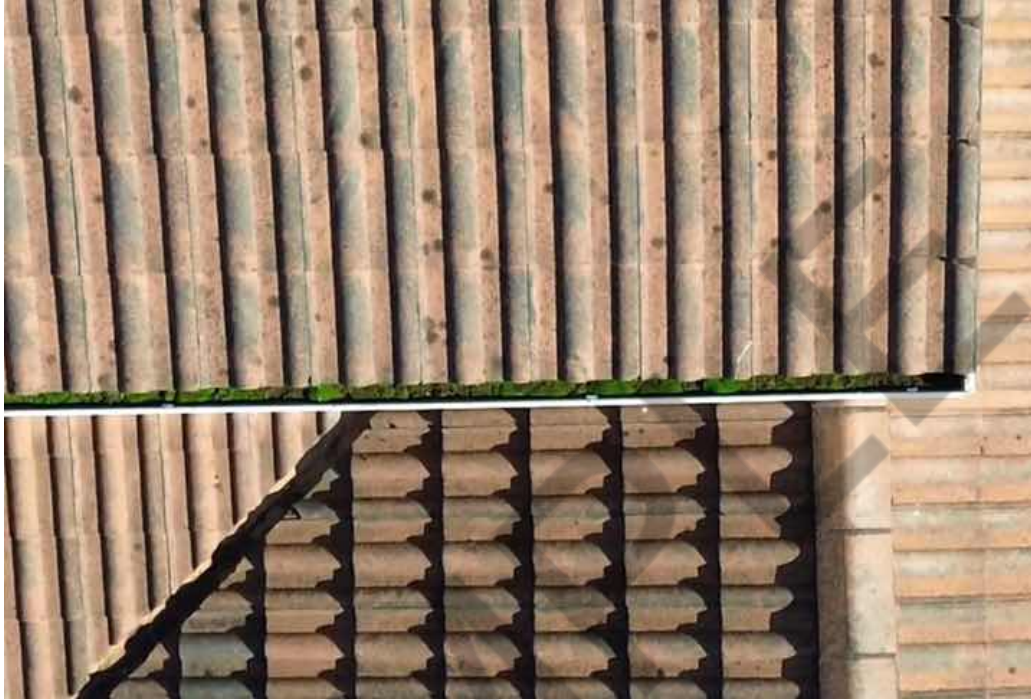
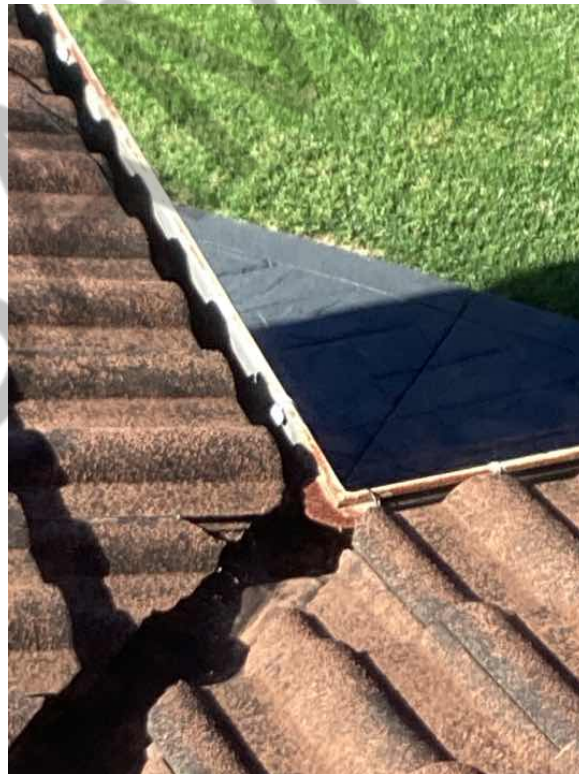
Debris in guttering areas- this requires cleaning out to prevent blocking of downpipes and leaking into eaves and fascia. Have gutters cleaned and assessed by a plumber for adequate fall. Regularly clean to prevent ponding. Ponding water will contribute to rust.

Gutter surface rust in sections- the rust is yet to penetrate and repairs/sealing may be an option. A qualified roof plumber should be engaged for advice and recommendations.

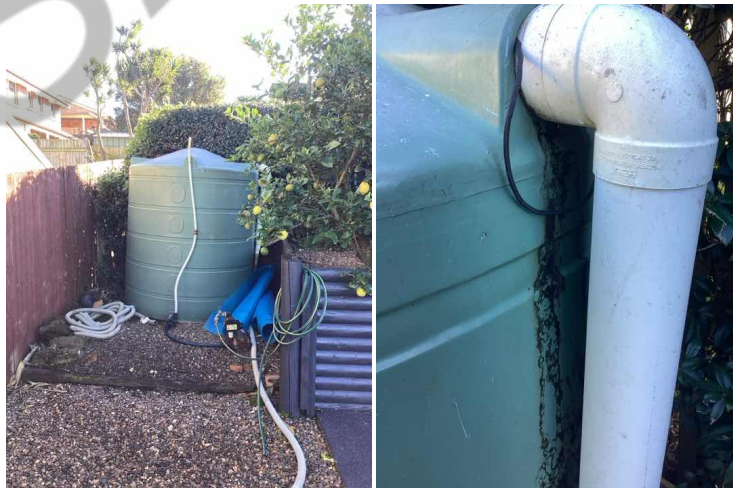
Leaking section. Recommendations: Assessment conducted by a licensed plumber advised.

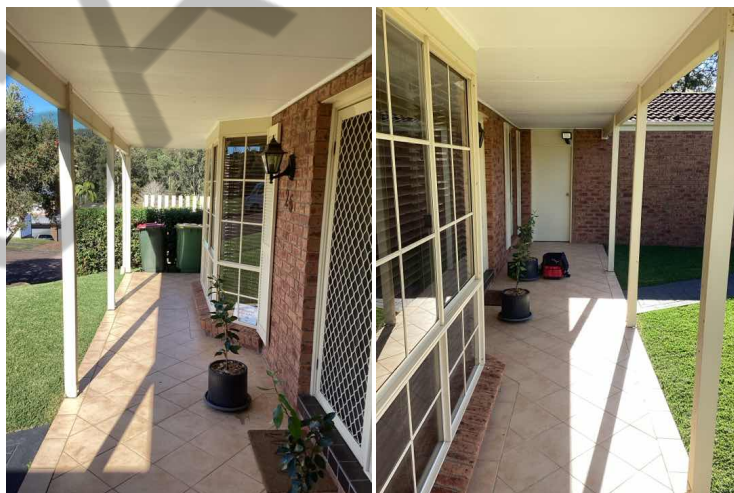
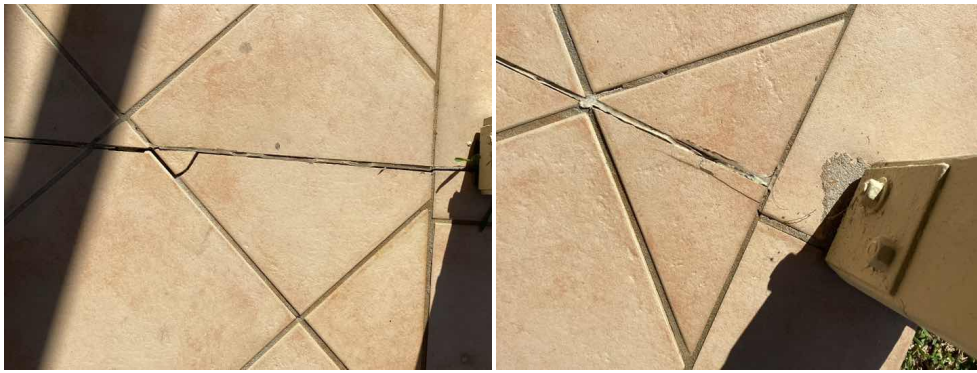
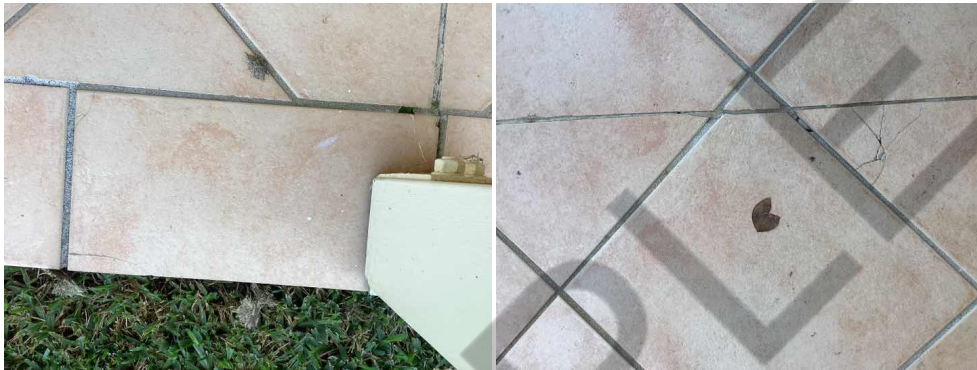
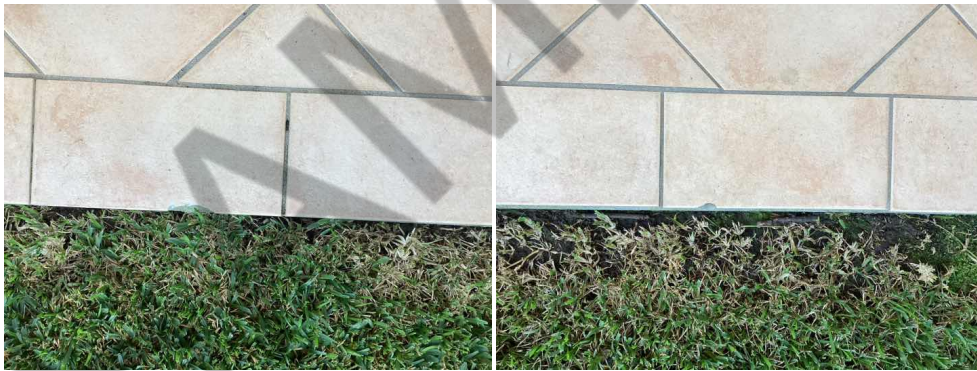
Cracked tiles noted. Repairs required by a qualified tiler.

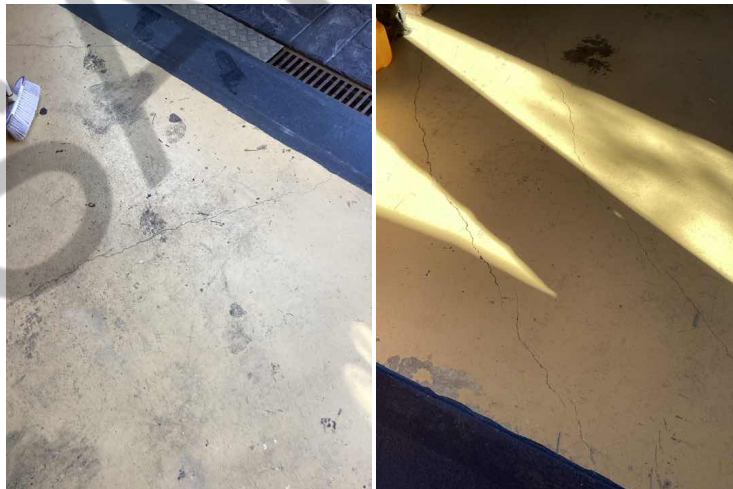
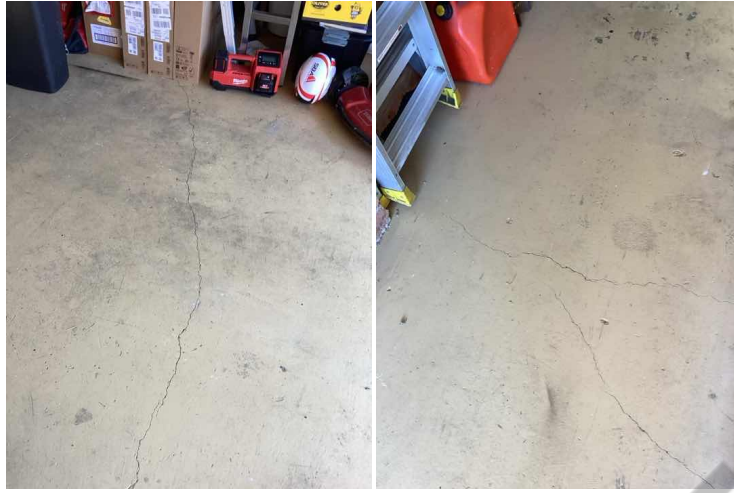
Minor hairline slab cracks - Note. Whilst these cracks appeared to be minor at the time of inspection, we strongly recommend you monitor these cracks and if worsening occurs contact a qualified concreter for further advice.

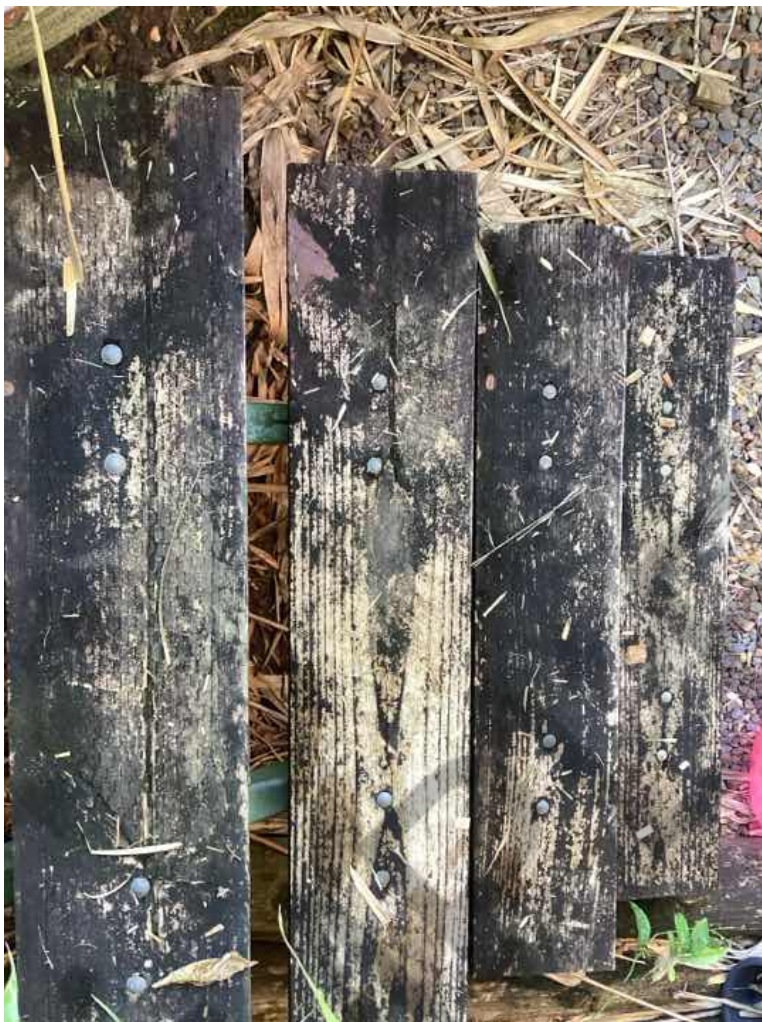
Timber fungal decay in sections of stair treads. Maintenance/repair is required. A qualified carpenter should be engaged for advice and recommendations.

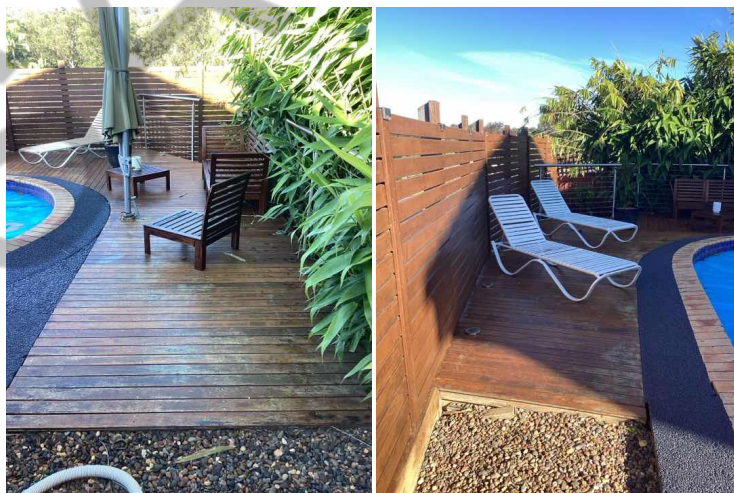
Of areas visible, the decking appears to be in a serviceable condition. Noted cracking in adjacent pool coping.

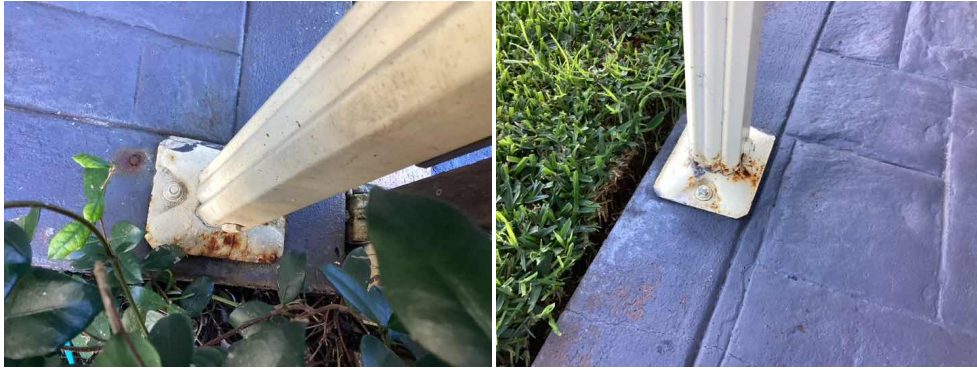
The foot brackets show signs of corrosion. Recommend Builder to assess and repair or replace accordingly.

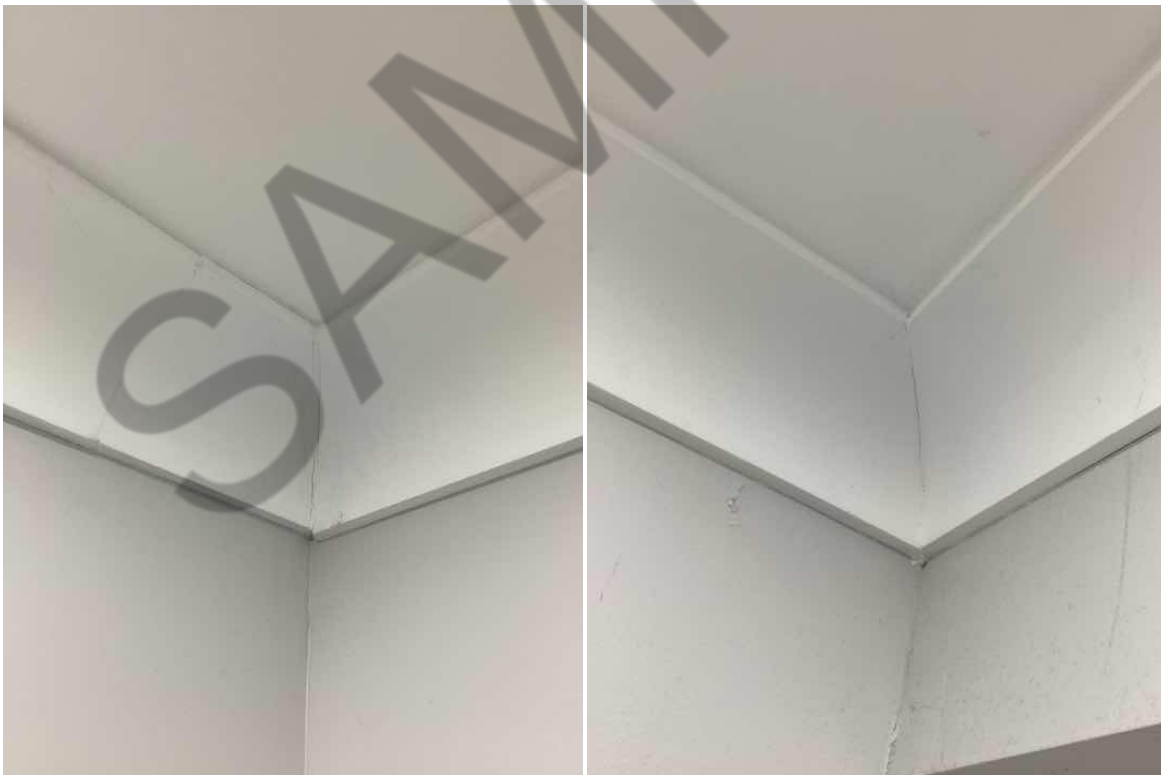
Settlement Cracks Noted. These are typical and generally patch and paint will suffice, however monitoring these cracks advised for 12 months and if they become wider or longer, you will need to contact a structural engineer to assess.

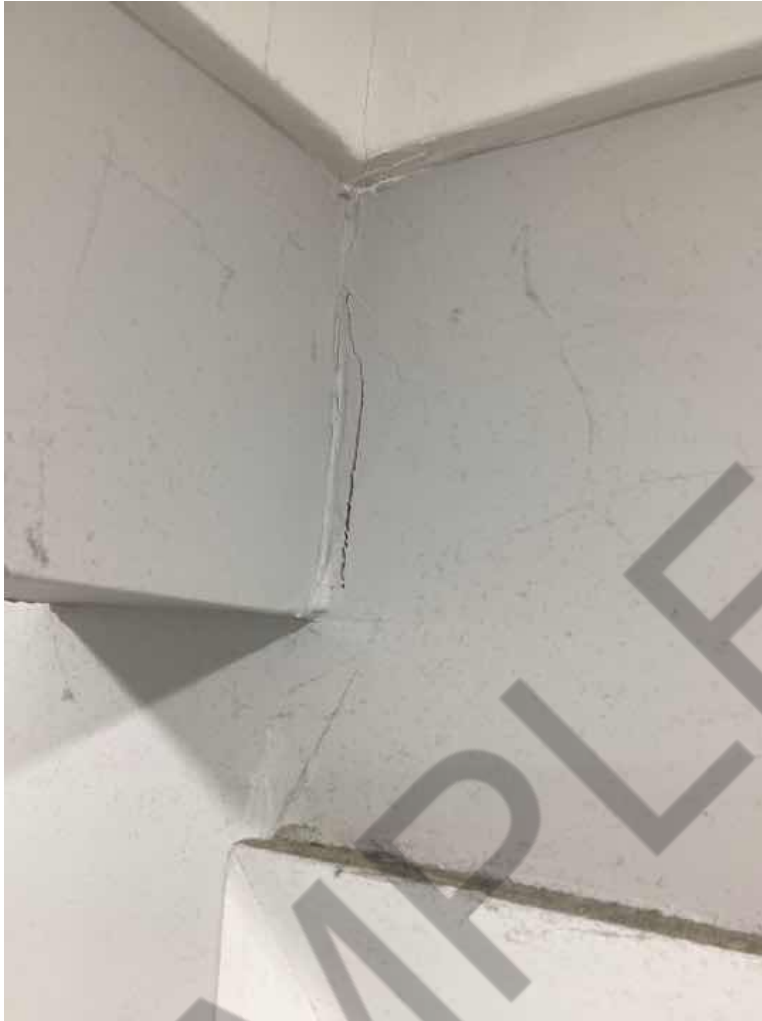
Settlement Cracks Noted . These are typical and generally patch and paint will suffice, however Monitoring these cracks advised for 12 months and if become wider or longer, you will need to contact a structural engineers to assess.

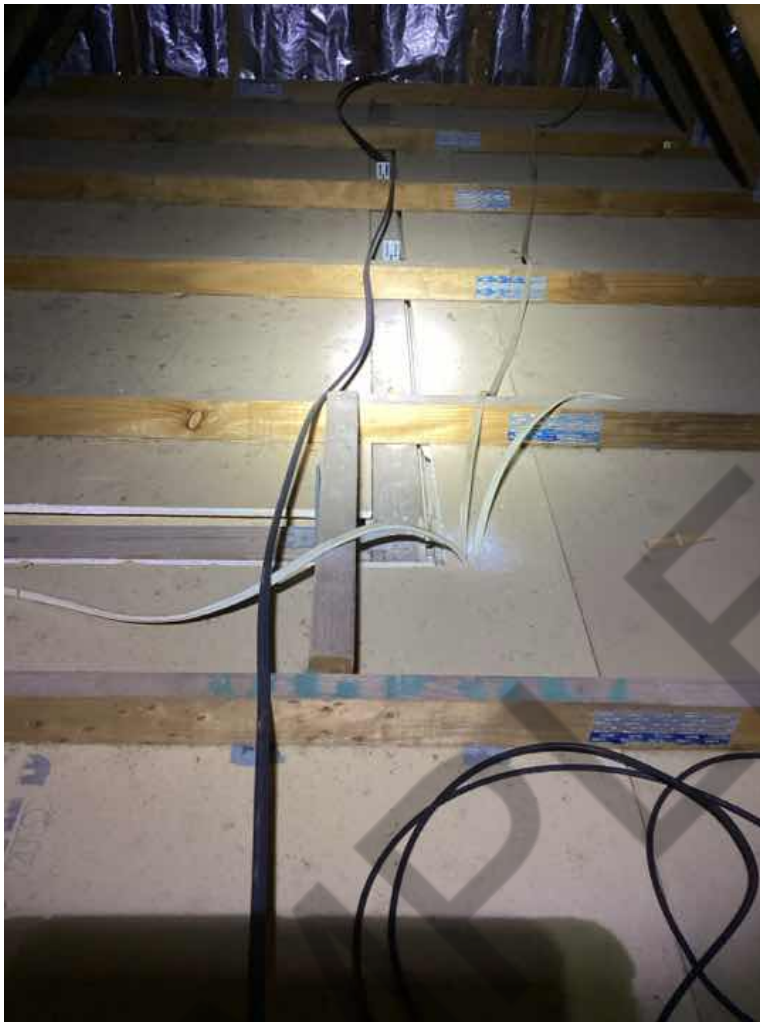
No insulation installed. Recommendations: Engage insulation contractor to assess.
