# Inspection Report

## Thorough Check Building Inspections

**25 Cherl Avenue, Terrigal, NSW, 2260**

### Pest And Building Inspection

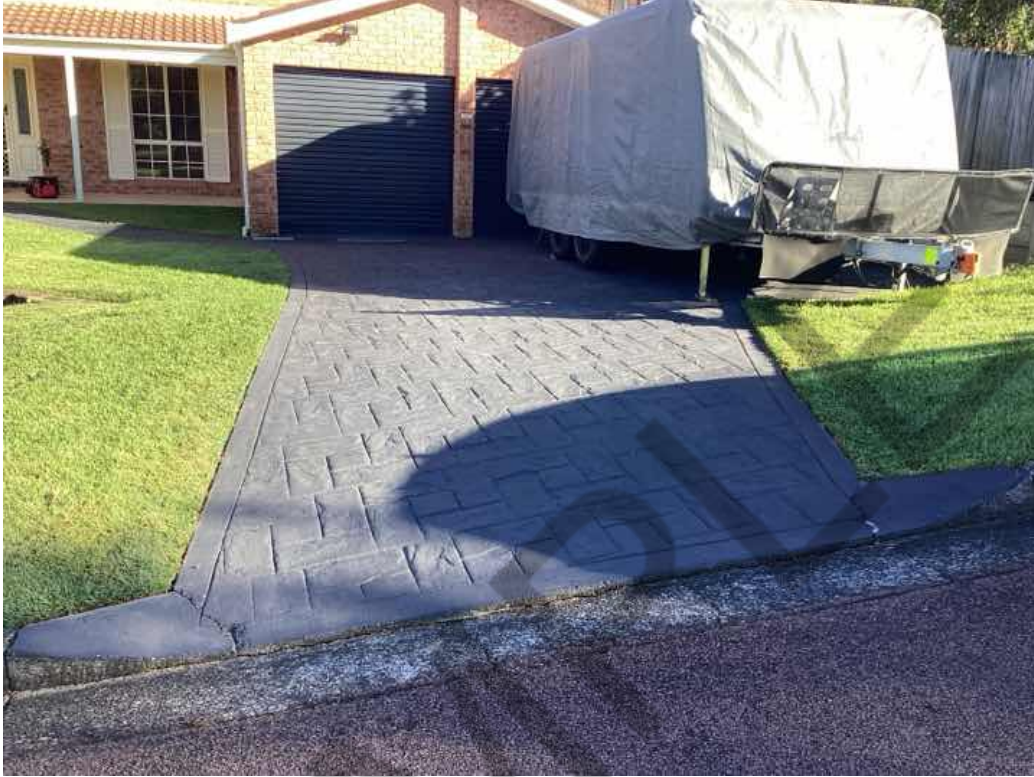
#### Driveway Condition

Common cracks were observed on the driveway. Whilst these cracks appeared to be typical at the time of inspection, we strongly recommend you monitor these cracks and if worsening occurs contact a concreter for further advice.

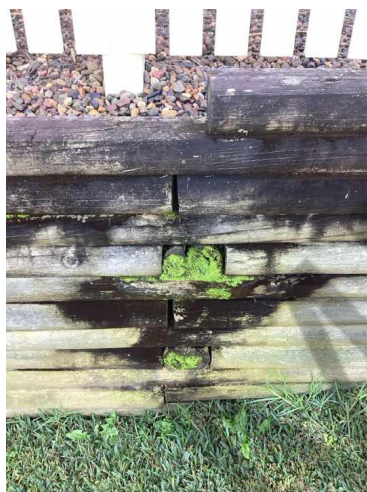
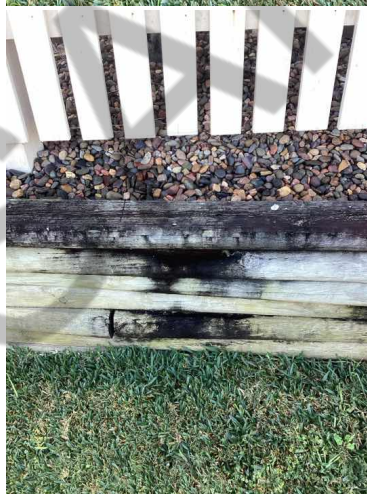
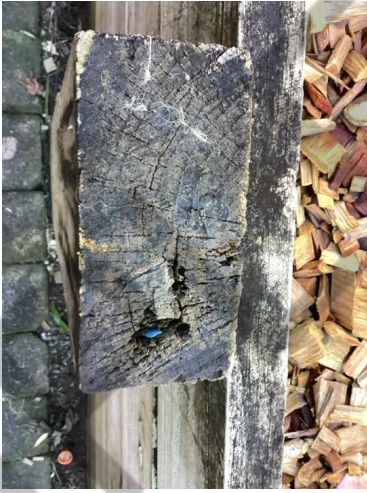
### Overall Condition

Timber fungal decay evident. Recommendations: A qualified landscaping contractor should be engaged for repairs and recommendations.

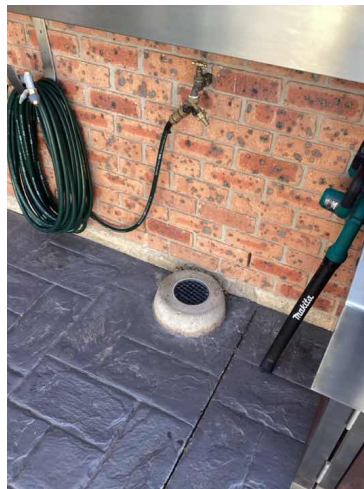
### Drains

Recommend installing a drainage point under the tap to assist with drainage.

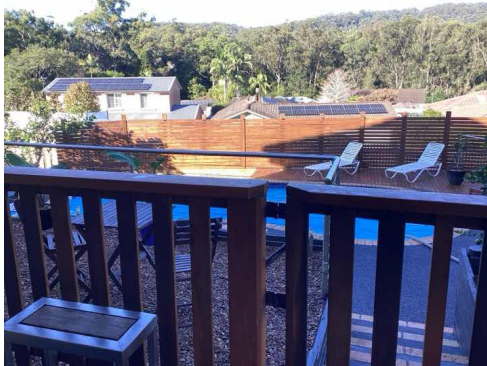
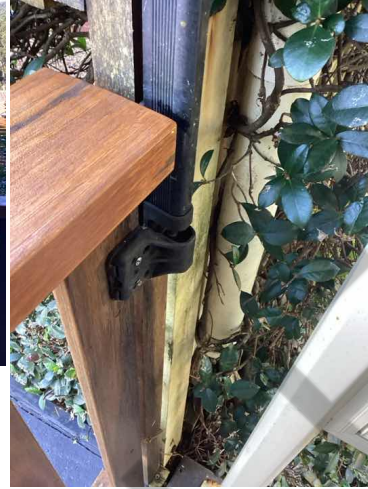
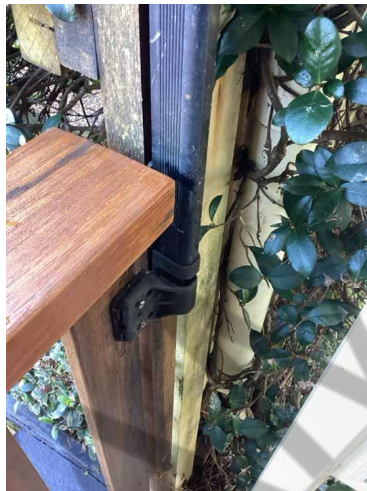
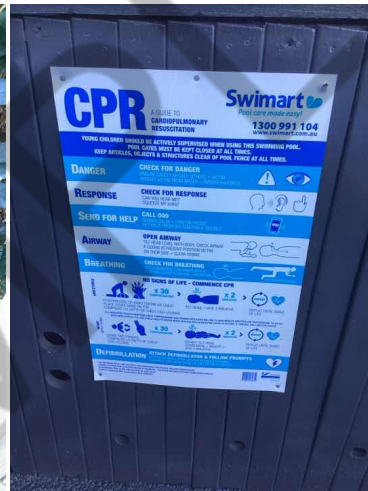
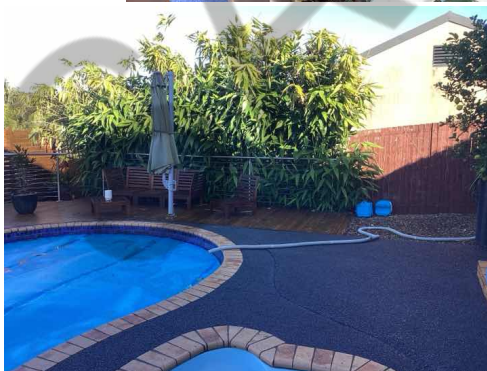
### Pool Fence

A swimming pool is present but the pool fence appears inadequate. The gate is not closing and latching as it should. This should be repaired. The pool fence should be checked for compliance with safety regulations. Considered safety Hazard

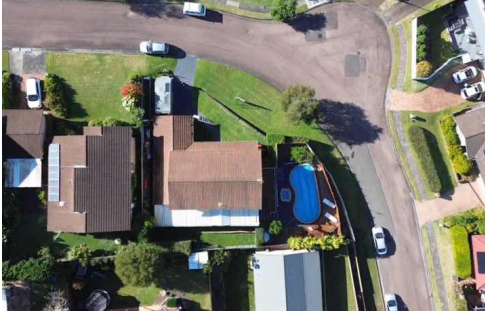
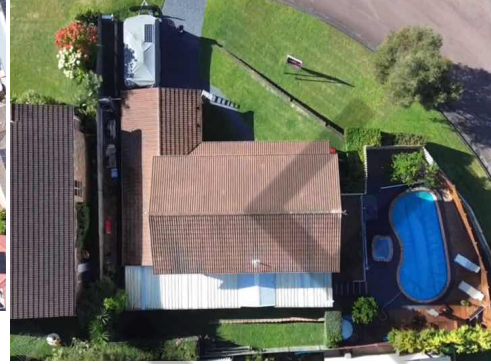
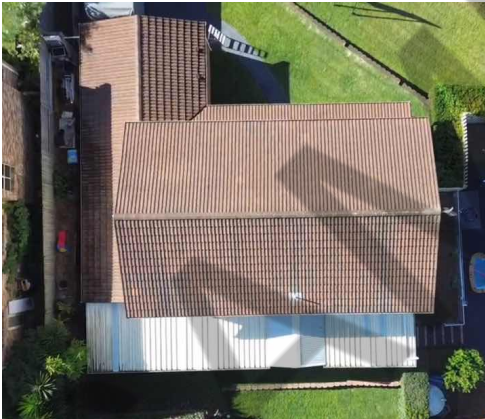
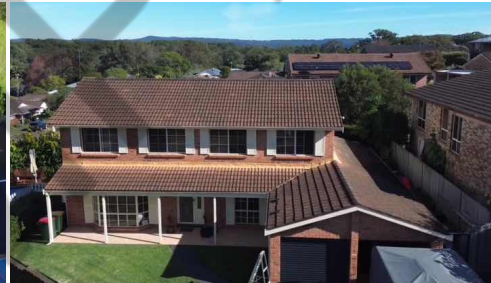
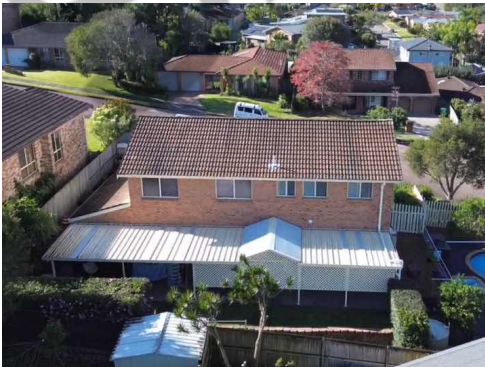
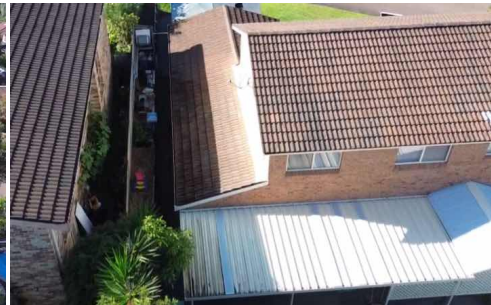
On inspection, defects were noted that may require further assessment and recommendations by licensed roofer.

Cracked tiles visible. Contact a roof tiler for repairs. This has potential to become a serious issue if repairs aren't carried out due to water ingress into the roof cavity.

Mortar cracks visible. We recommend having these repaired by a qualified roofer as they may contribute to water ingress.

Cracked tile ends visible. A qualified roof tiling contractor should be engaged for advice and recommendations. Considered a minor defect but has the potential to become a Major defect if repairs aren't carried out immediately due to water ingress into the roof cavity.

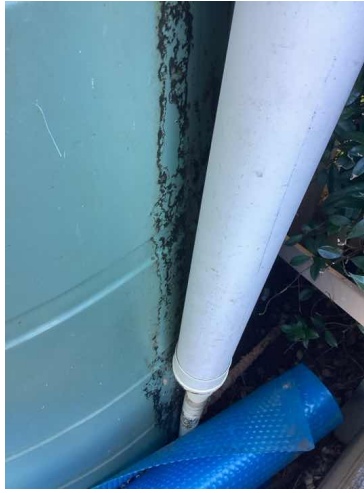
### Water Tank Condition

Leaking section. Recommendations: Assessment conducted by a licensed plumber advised.

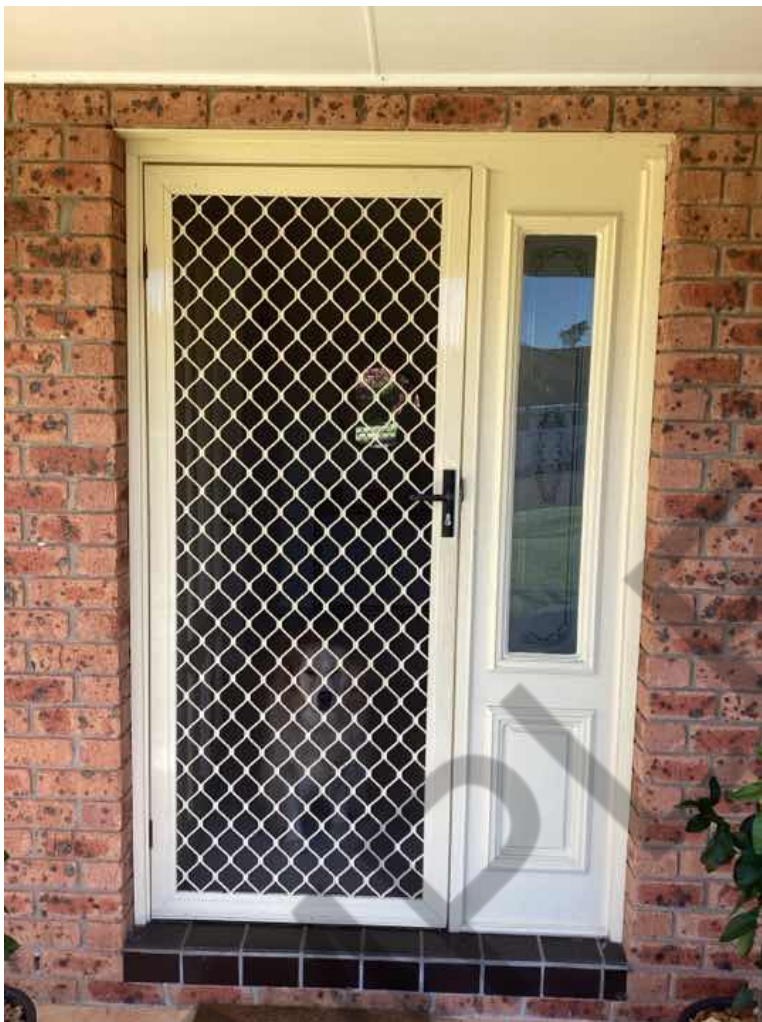
### **Porch Findings**

Cracked tiles noted. Repairs required by a qualified tiler.

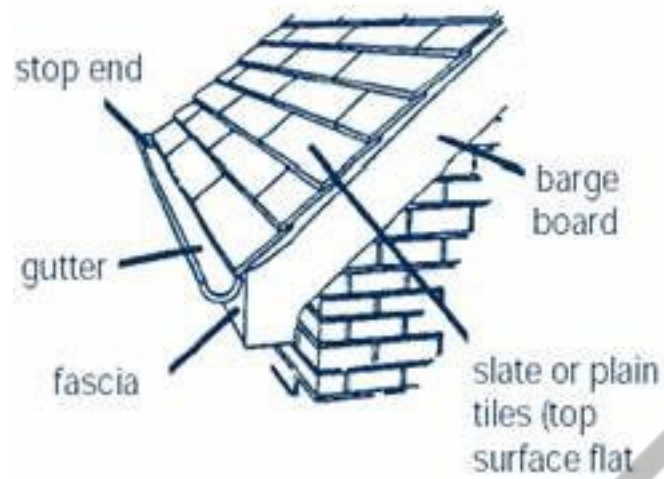
### **Condition**

On visual inspection, the general condition of the fascia/barge boards is serviceable.

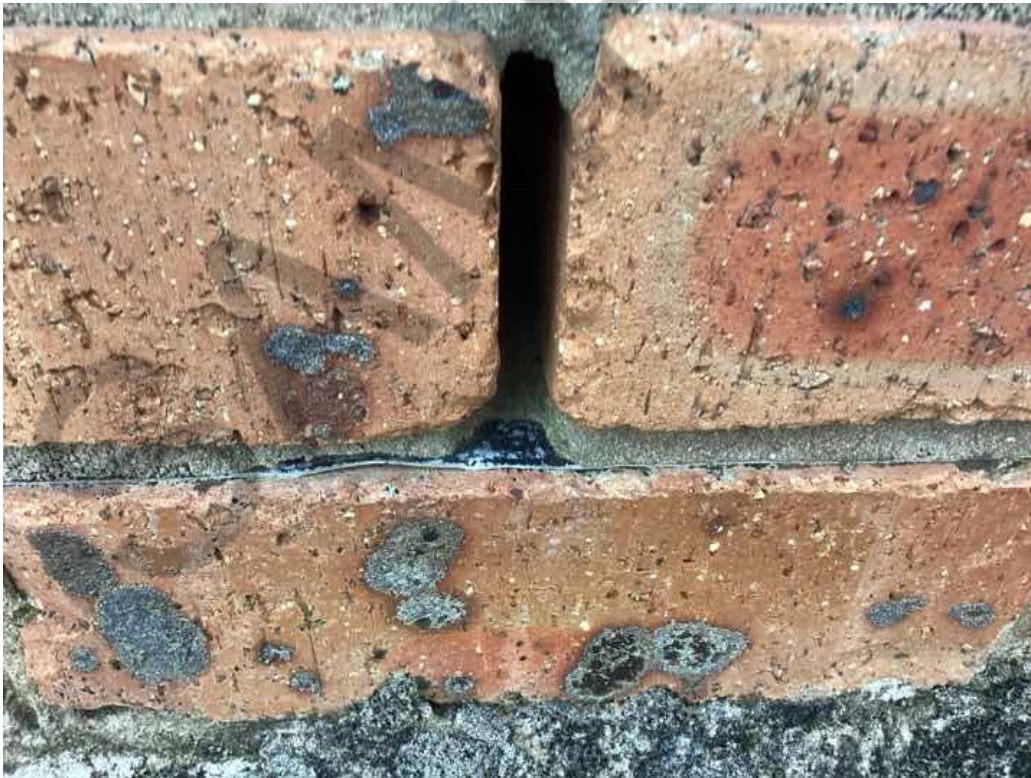
### **Damp Proof Course**

A damp proof course (DPC) was noted.

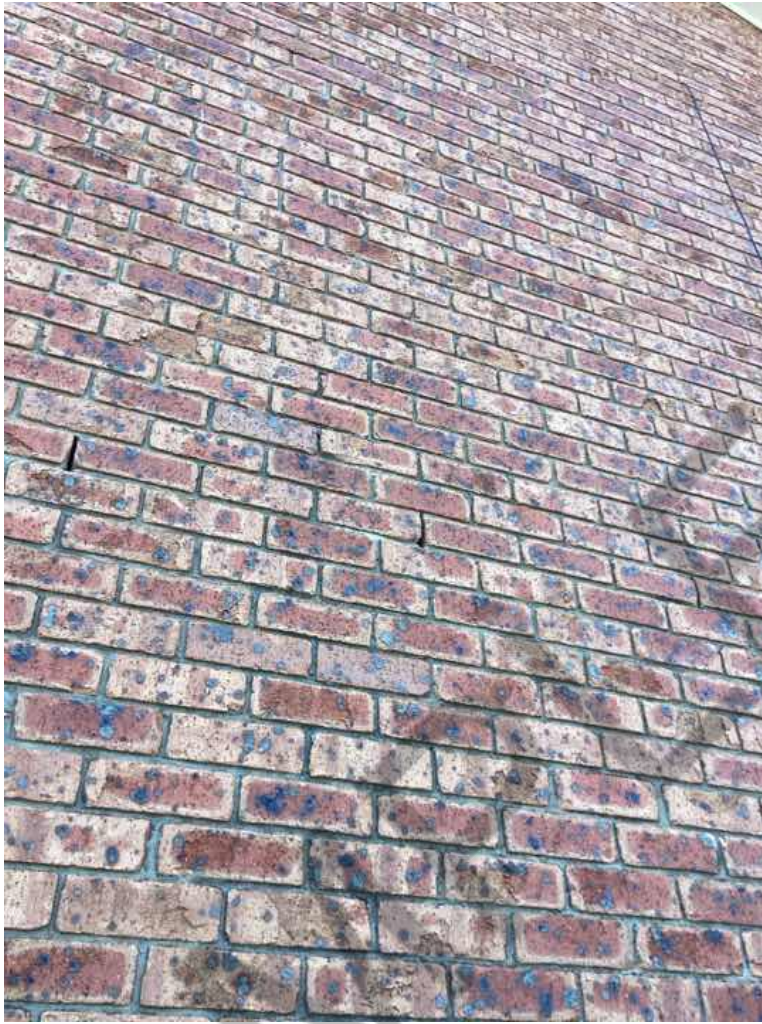
### **Exterior Wall Material**

Brick.

On visual inspection, the general condition of the exterior walls is serviceable for the age.

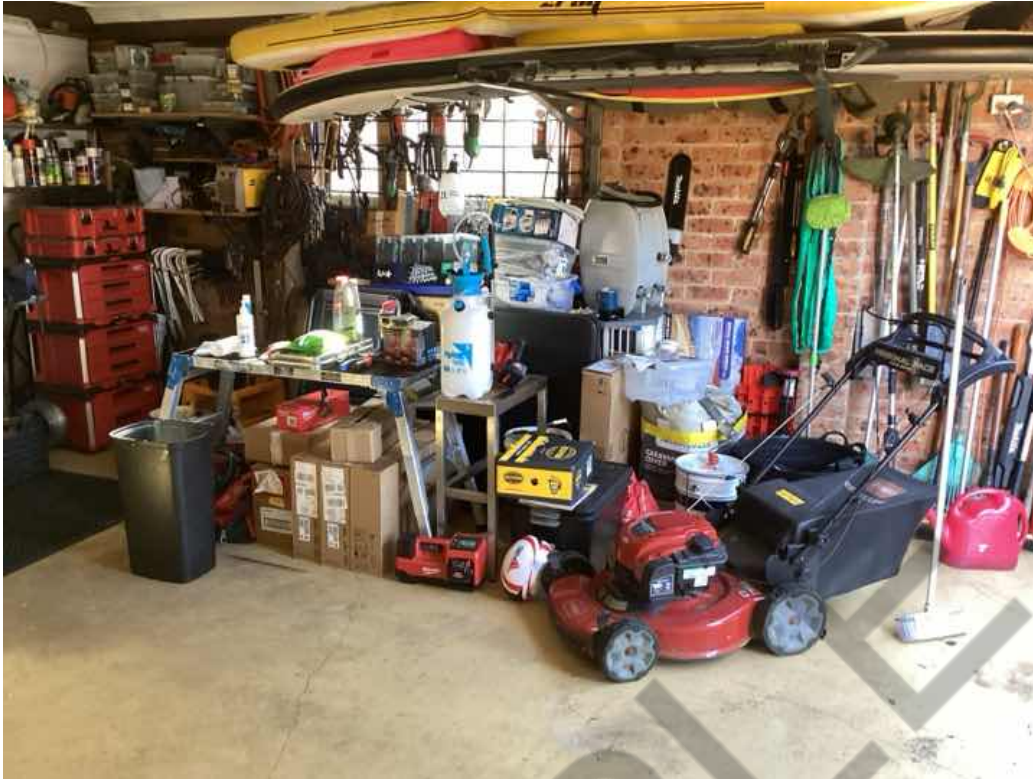
#### Areas Restricted

Stored items restricted a full and thorough inspection of this area. Defects may exist in the obstructed and inaccessible areas. It is strongly recommended that full access be granted to enable a thorough inspection as there may be timber pest activity, damage or defects. Note: Where vehicles and storage has restricted a full inspection it is advised that this area be cleared so a full and unobstructed inspection can be carried out.

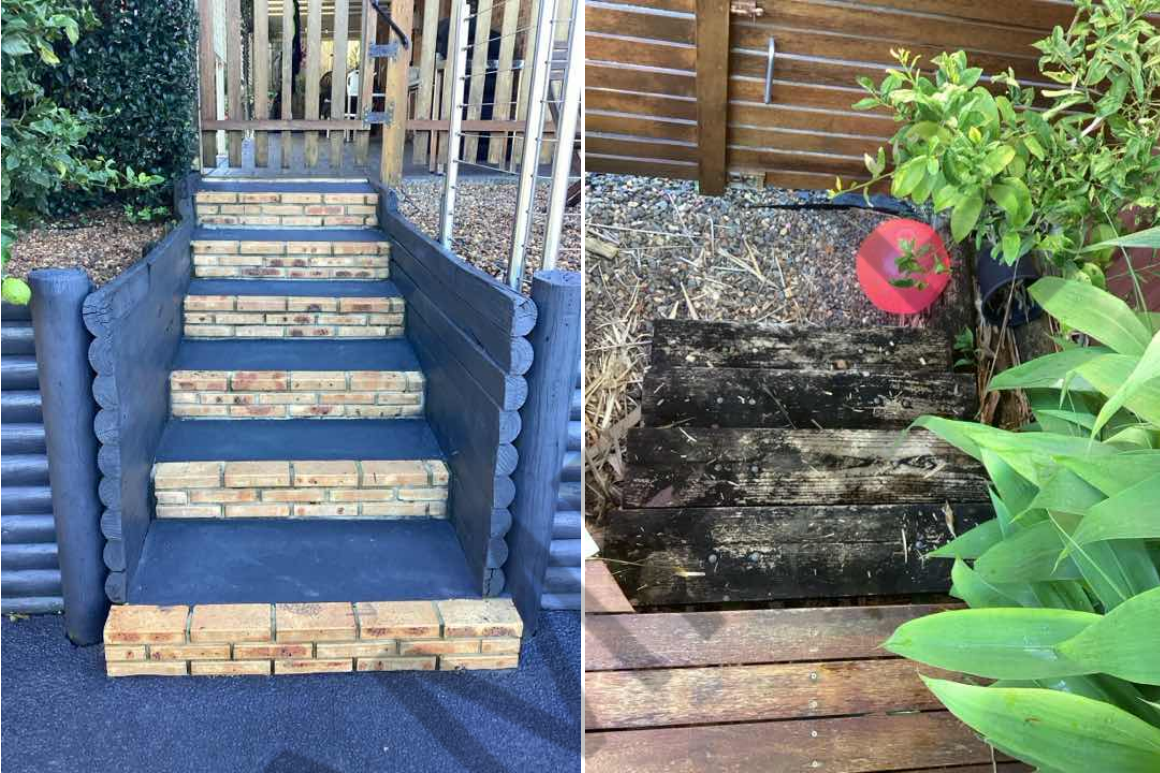
#### Treads

Timber fungal decay in sections of stair treads. Maintenance/repair is required. A qualified carpenter should be engaged for advice and recommendations.

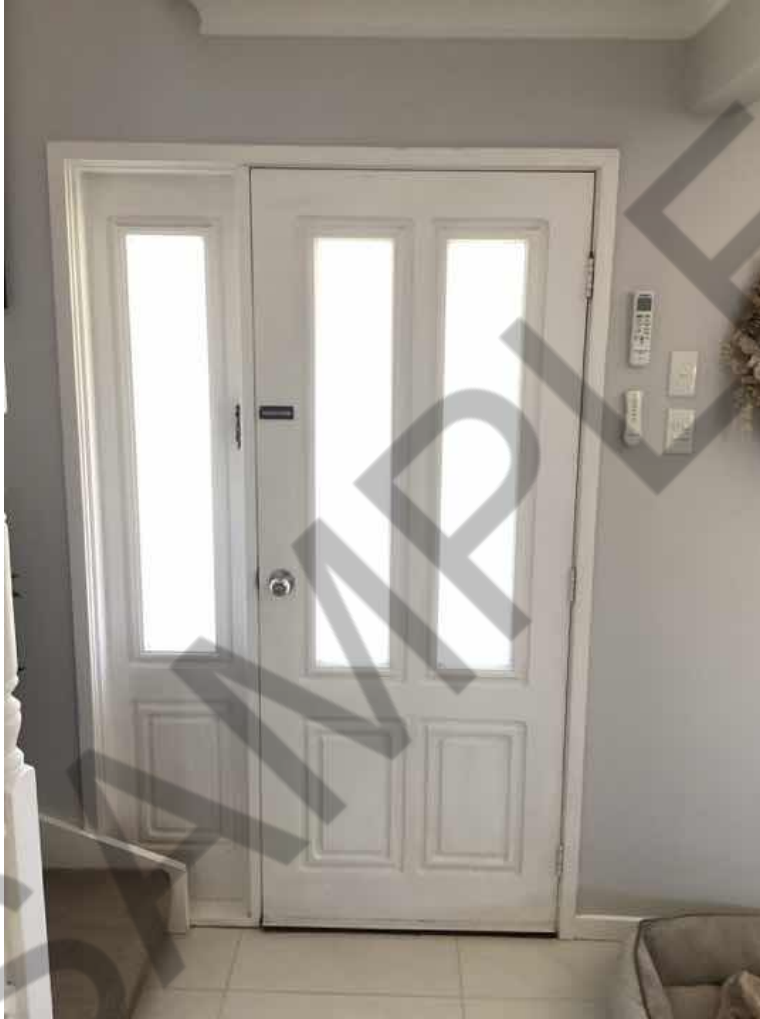
#### **Front Entry Doors**

The doors are in serviceable condition with no notable defects observed.

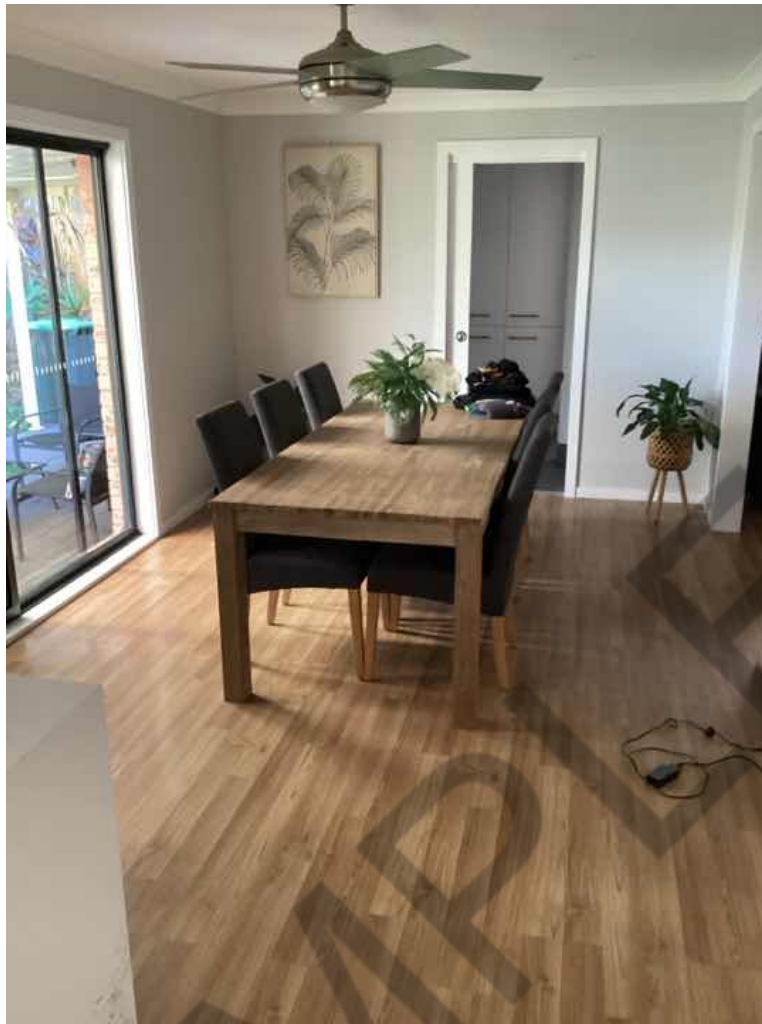
## Dining Room

From the visible and accessible areas, this room appears to be in a serviceable condition for the age of the property with no notable structural defects sighted.

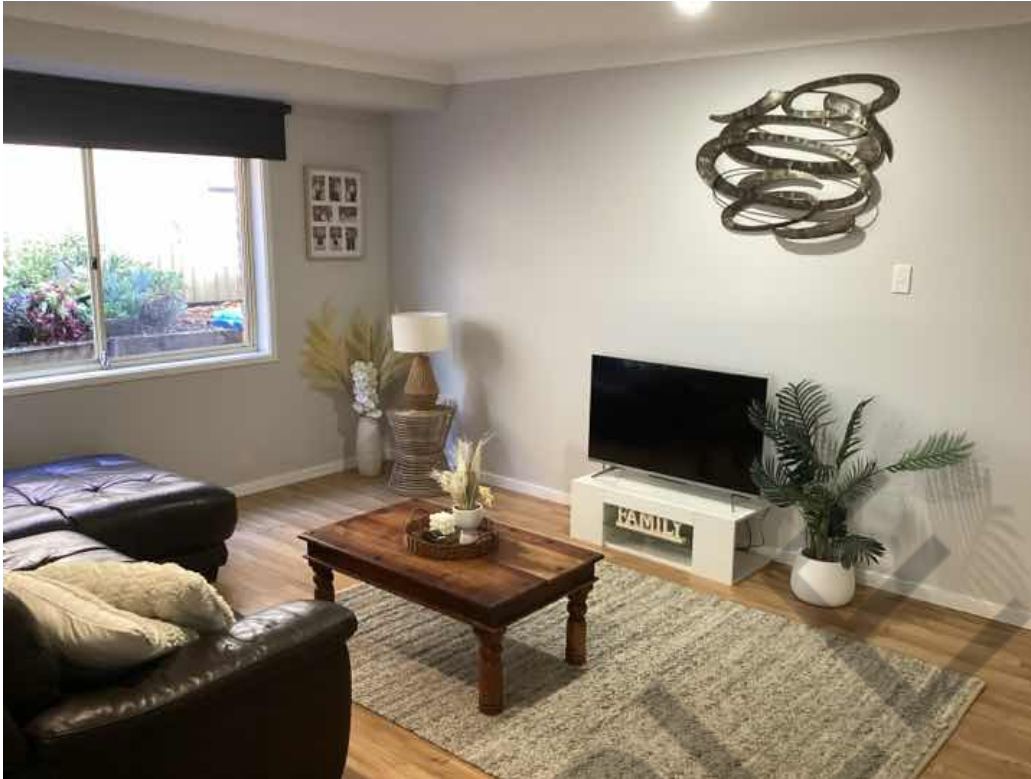
## **Family Room**

From the visible and accessible areas, this room appears to be in a serviceable condition for the age of the property with no notable structural defects sighted.

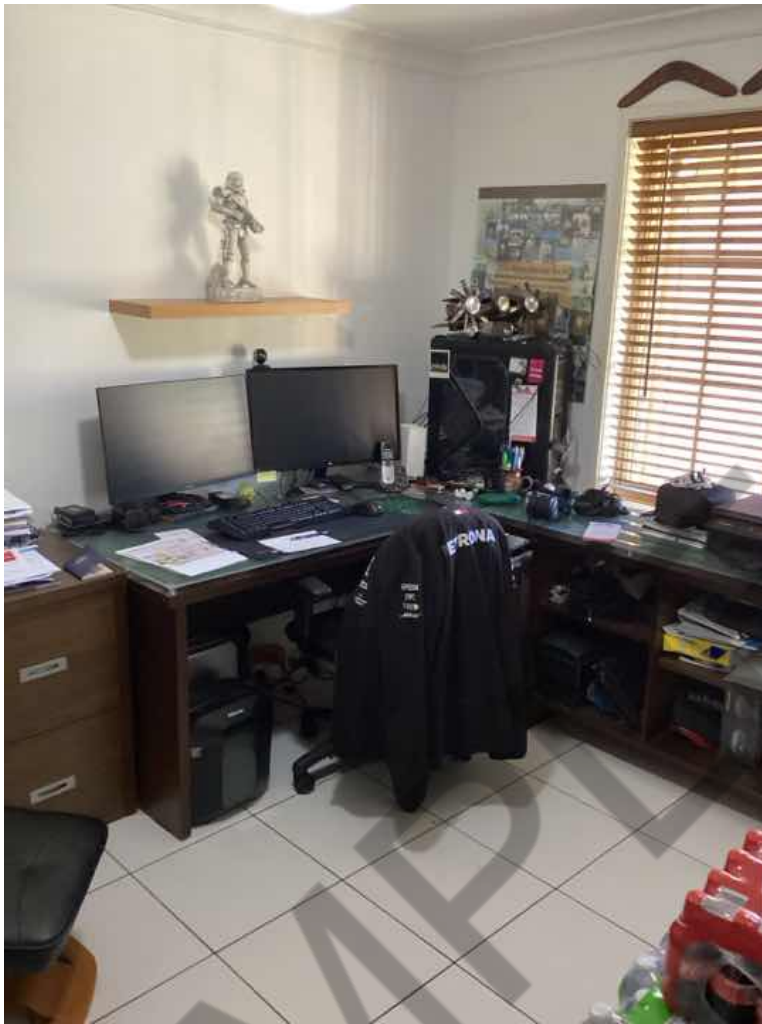
## Study

From the visible and accessible areas, this room appears to be in a serviceable condition for the age of the property with no notable structural defects sighted.

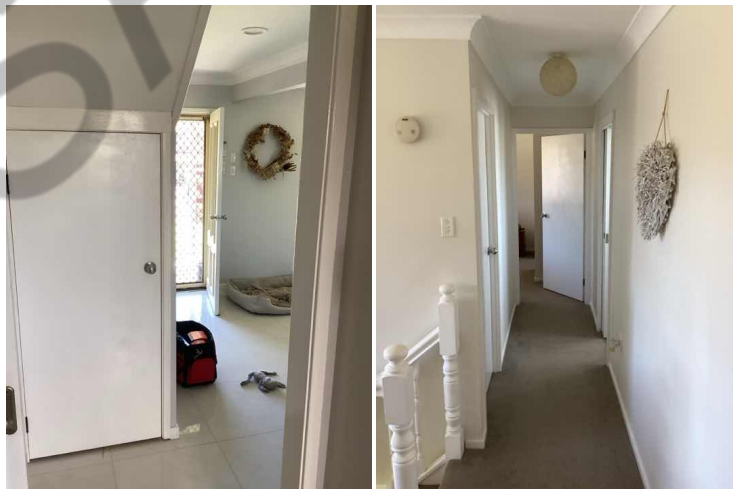
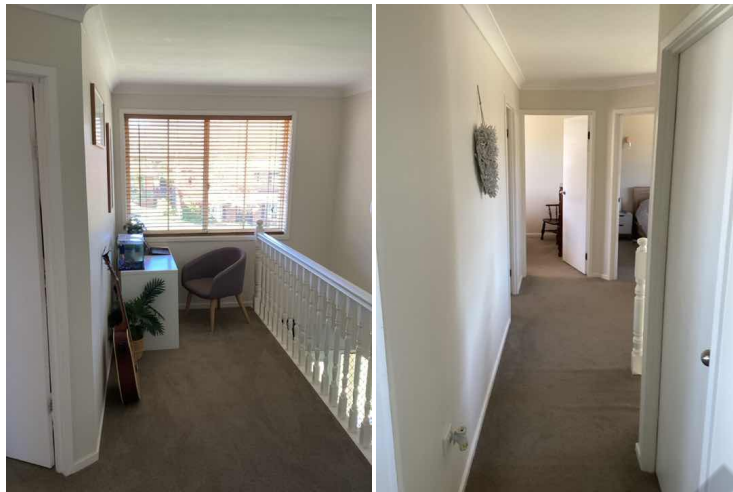
**Hallway/s**

From the visible and accessible areas, the hallway/ appears to be in a serviceable condition for the age of the property with no notable structural defects sighted.

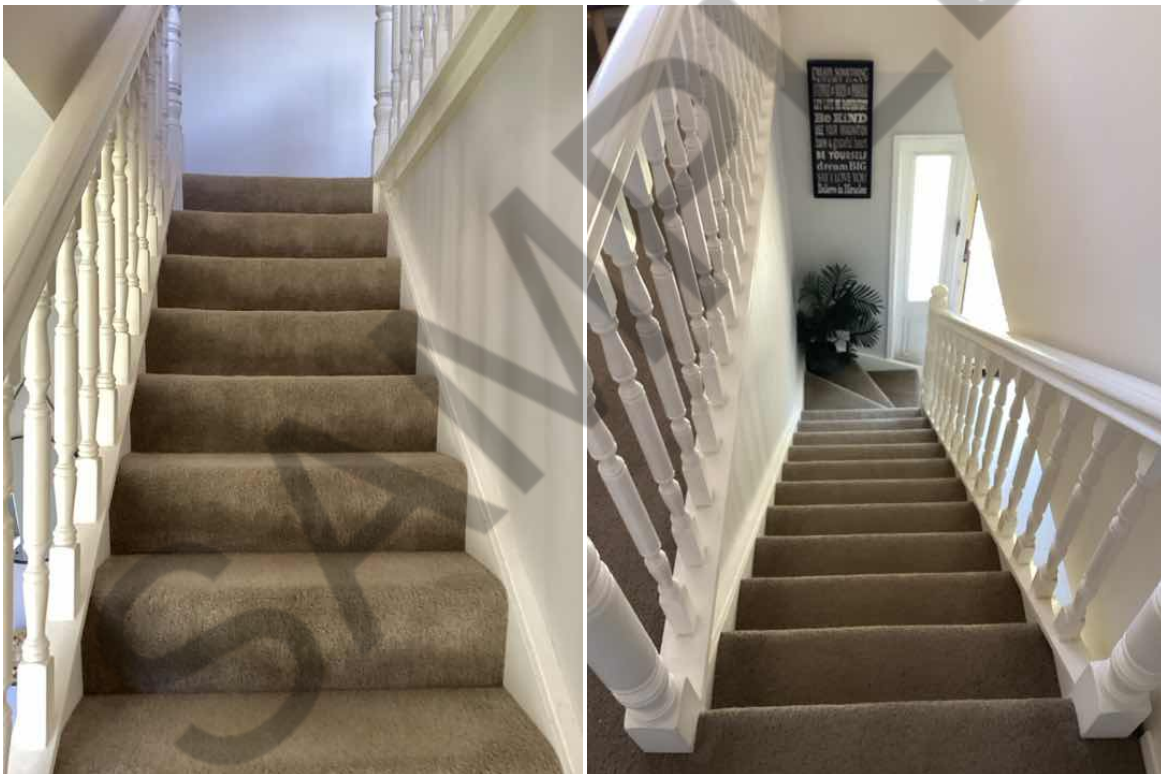
## Internal Stair Case

The internal staircase and components appear to be in a serviceable condition for the age with no notable defects sighted.

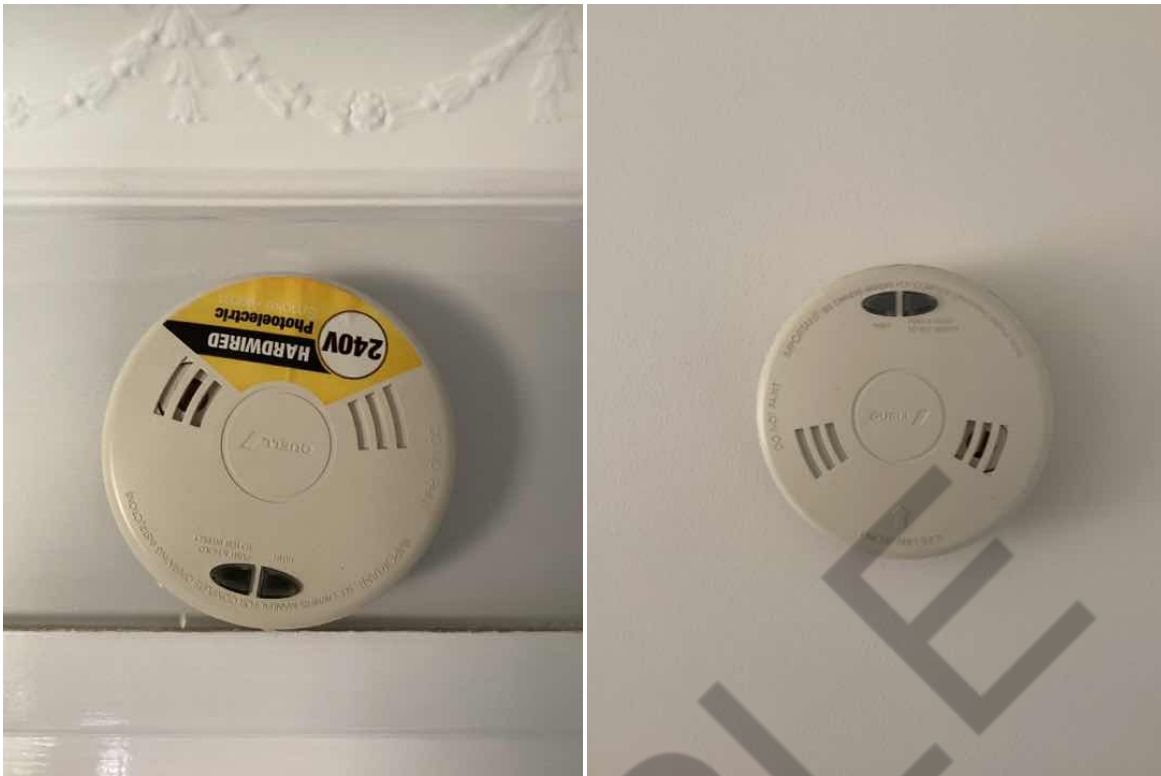
## Smoke Alarm

Yes 2 smoke alarms were sighted but not tested.

Legislation requires smoke Alarms to be installed. Check with your local council regarding type, locations and other related requirements.

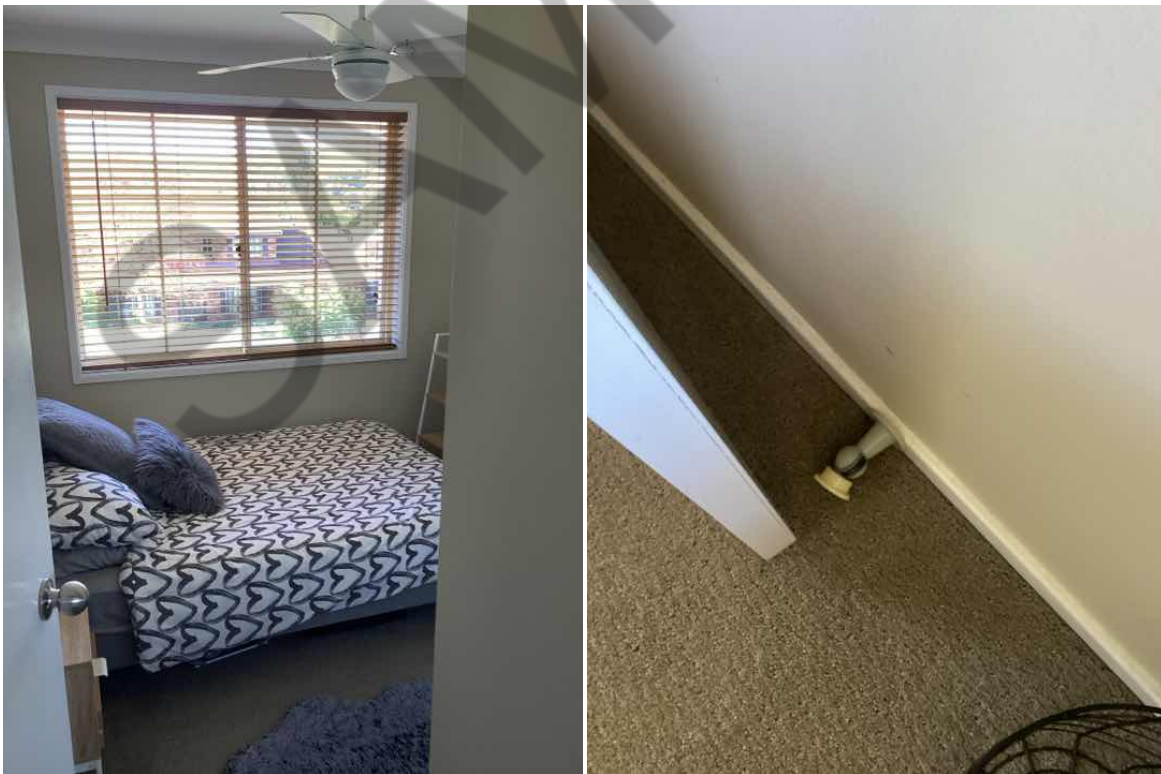
## Bedroom 1

From the visible and accessible areas, this bedroom appears to be in a serviceable condition for the age of the property with no notable structural defects sighted. Noted door stop has loose fixings.

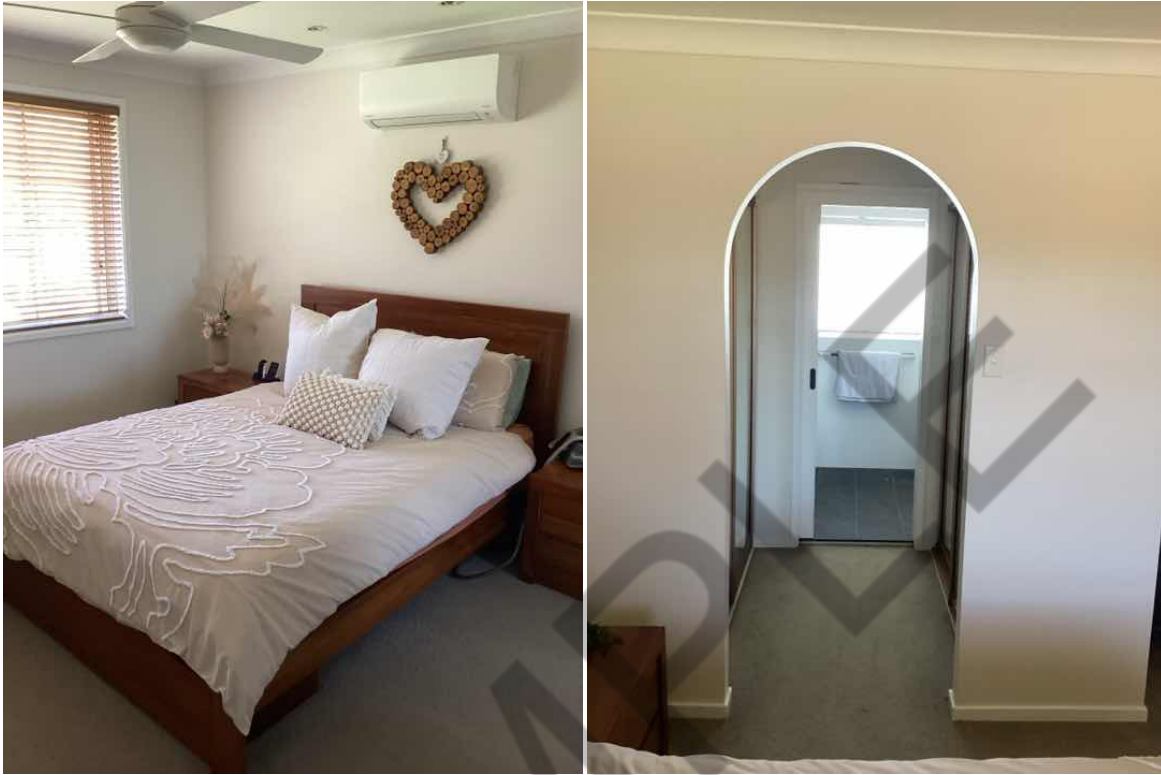
## **Bedroom 2**

From the visible and accessible areas, this bedroom appears to be in a serviceable condition for the age of the property with no notable structural defects sighted.

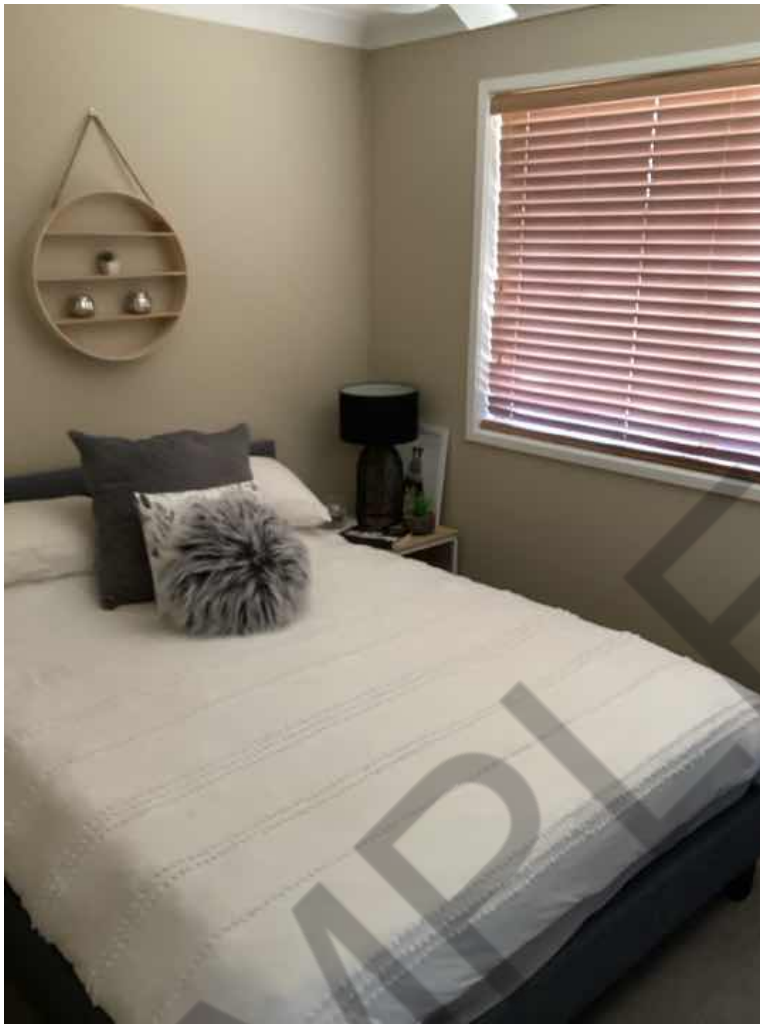
## **Bedroom 3**

From the visible and accessible areas, this bedroom appears to be in a serviceable condition for the age of the property with no notable structural defects sighted.

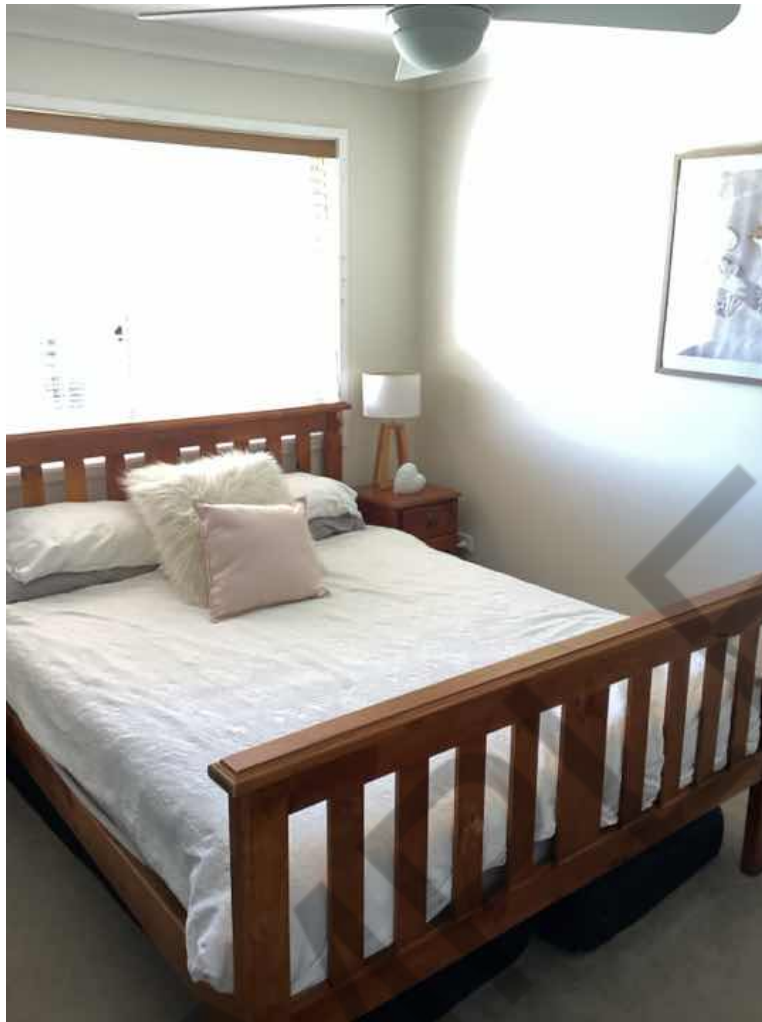
#### **Bedroom 4**

From the visible and accessible areas, this bedroom appears to be in a serviceable condition for the age of the property with no notable structural defects sighted.

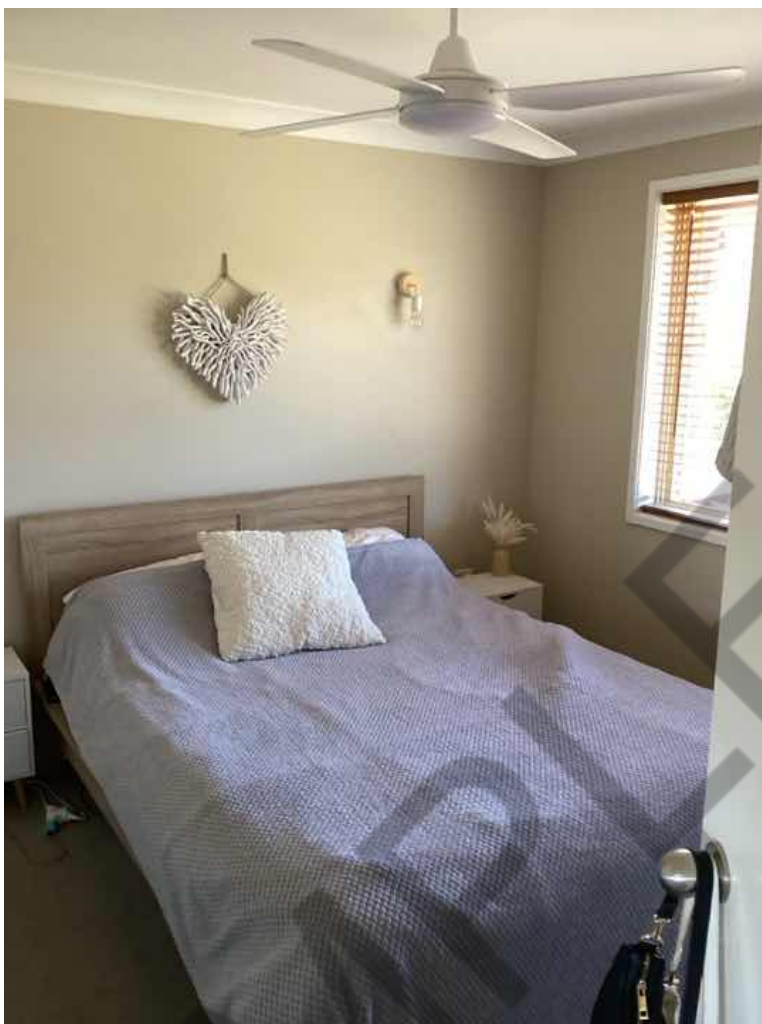
## **Bedroom 5**

From the visible and accessible areas, this bedroom appears to be in a serviceable condition for the age of the property with no notable structural defects sighted.

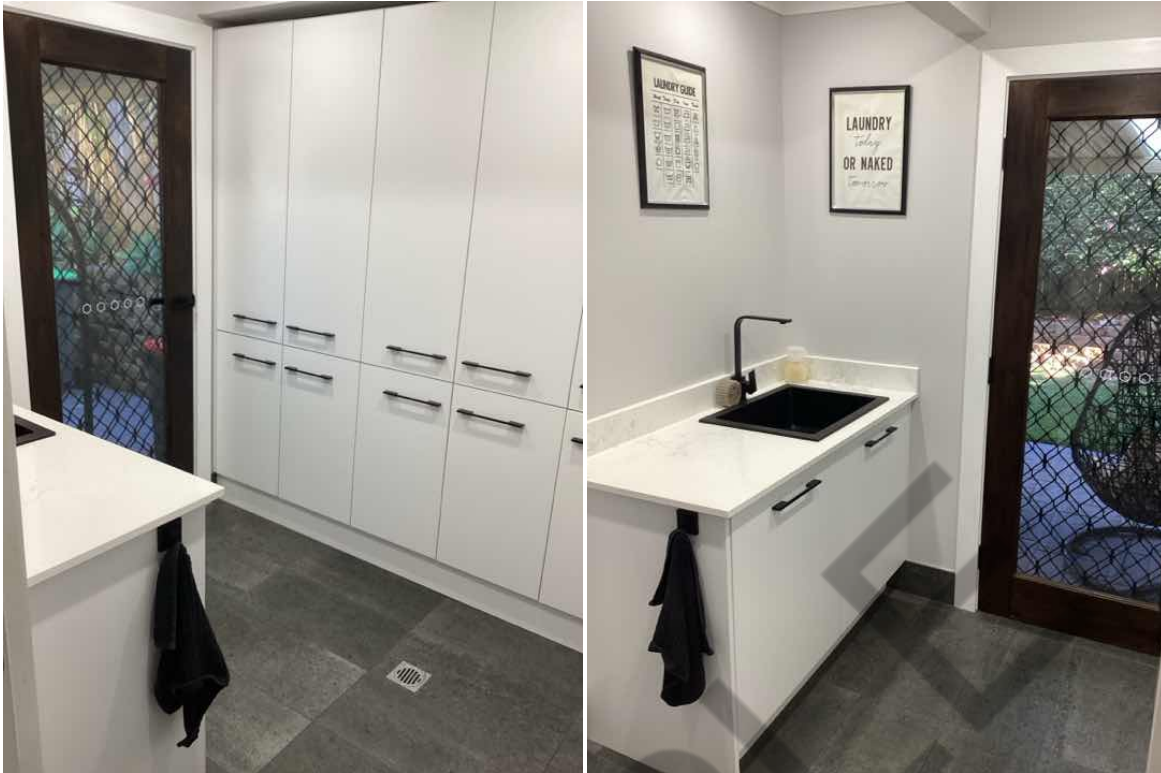
### Ceiling

Settlement Cracks Noted. These are typical and generally patch and paint will suffice, however monitoring these cracks advised for 12 months and if they become wider or longer, you will need to contact a structural engineer to assess.

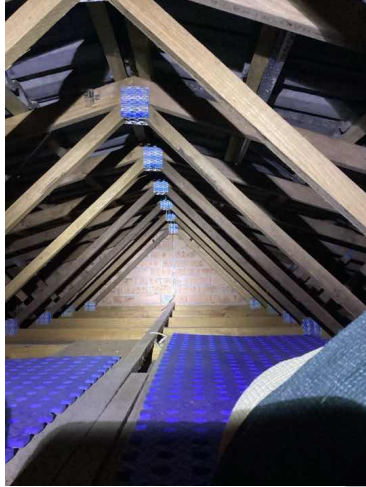
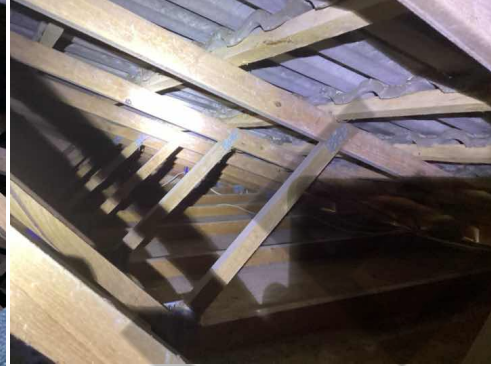
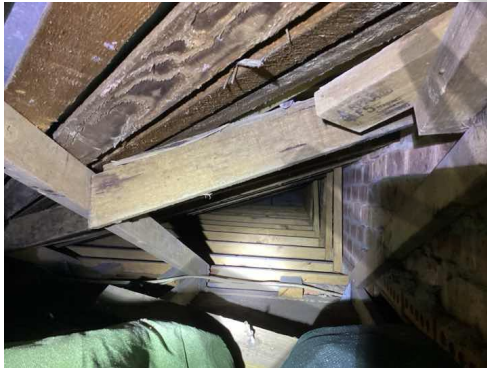
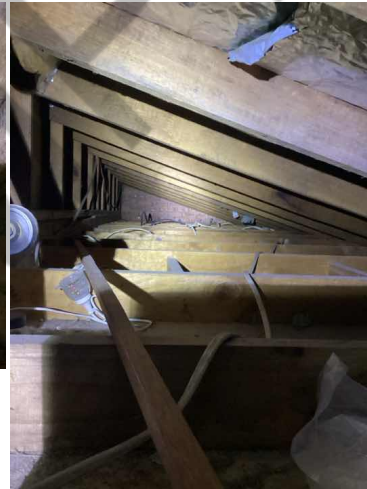
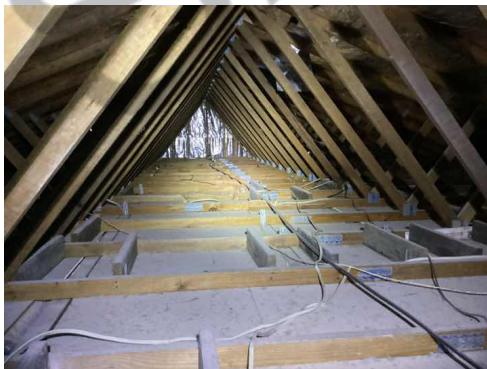
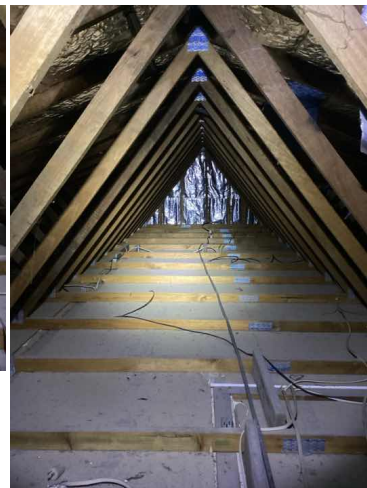
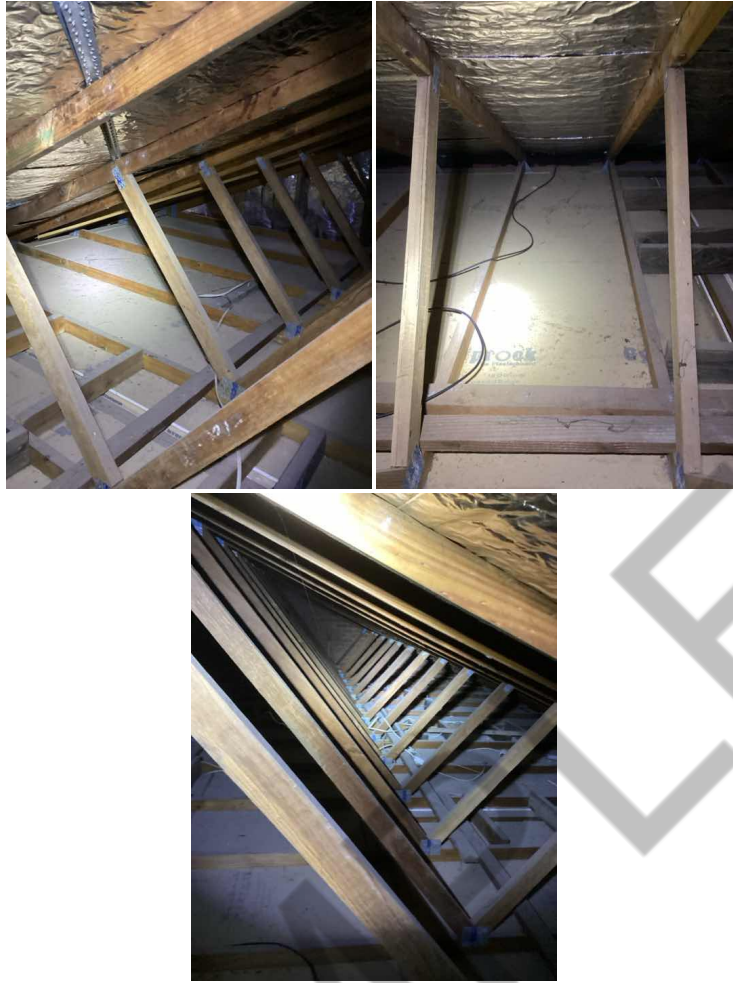
#### Roof Frame Type

The roof frame is a truss timber frame.

Visible sections of the roof void is in a serviceable condition for age of this dwelling.

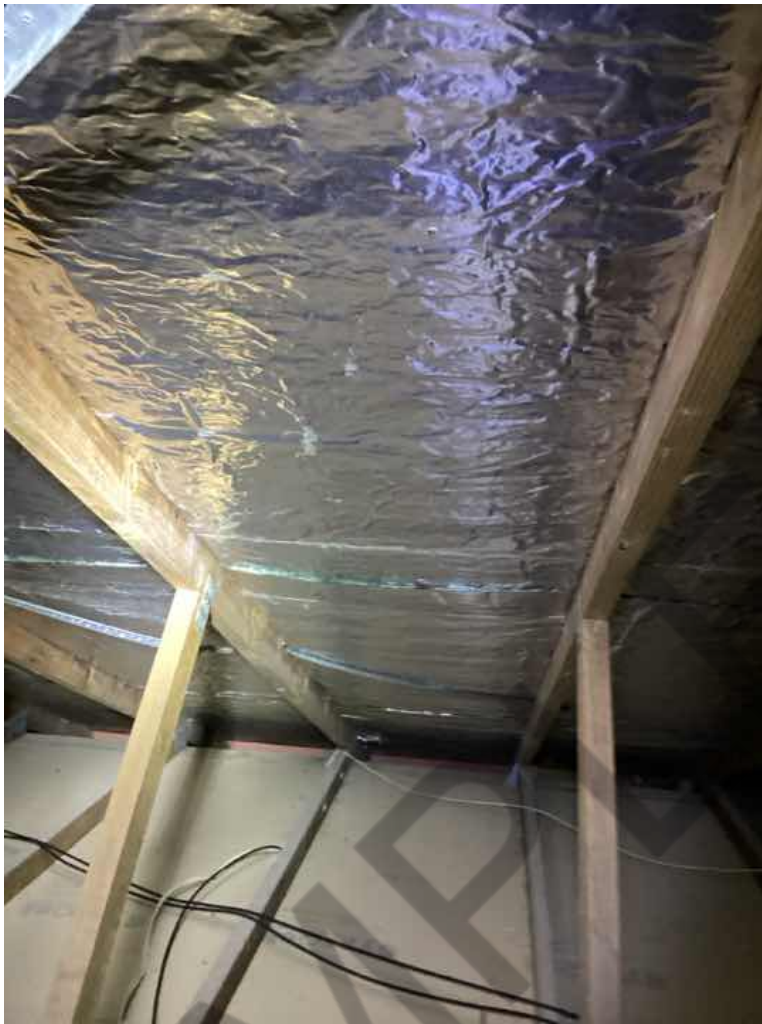
The sarking generally is in a serviceable condition.

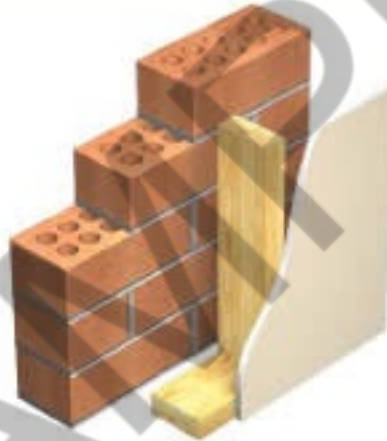
**BRICK VENEER WALL**

The structure is of brick veneer construction.
