# Inspection Report

## Thorough Check Building Inspections

**25 Cherl Avenue, Terrigal, NSW, 2260**

### Pest And Building Inspection

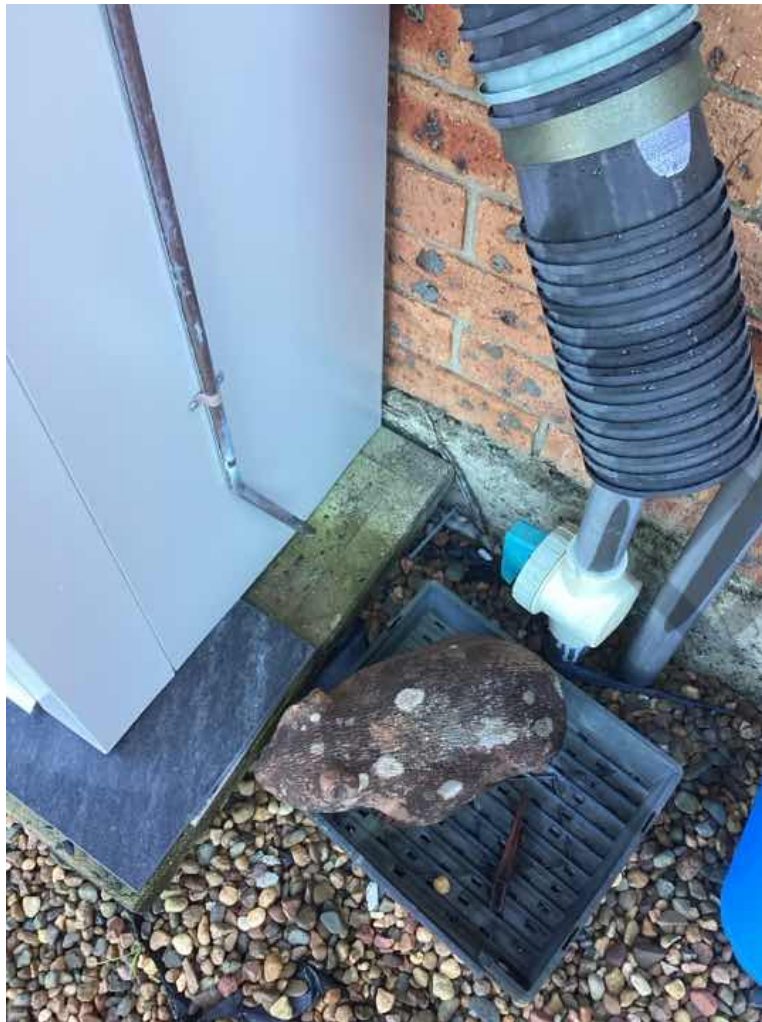
#### **Was the overflow sufficiently drained**

No. Divert hot water overflow away from the building perimeter.

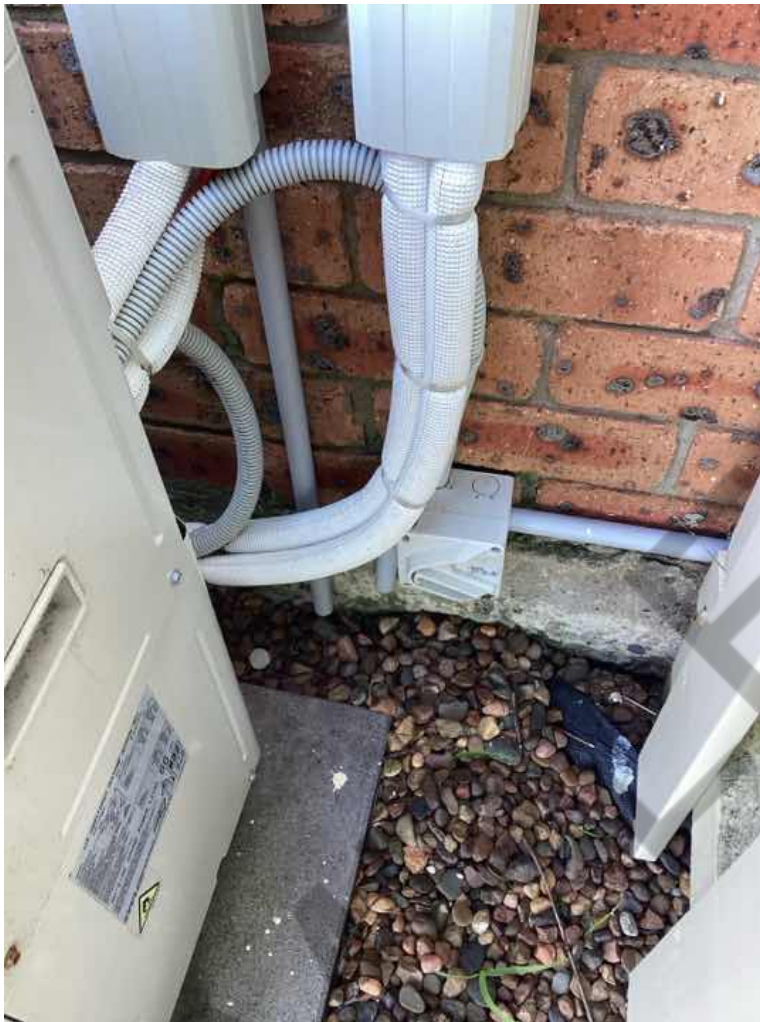
**Was the Air Conditioner Sufficiently Drained**

No - Divert A/C overflow away from the building perimeter.
